August 30, 2019

Mr. Craig Bessinger, City Manager
City of Ferrysburg
17290 Roosevelt Road
PO Box 38
Ferrysburg, MI 49409-0038

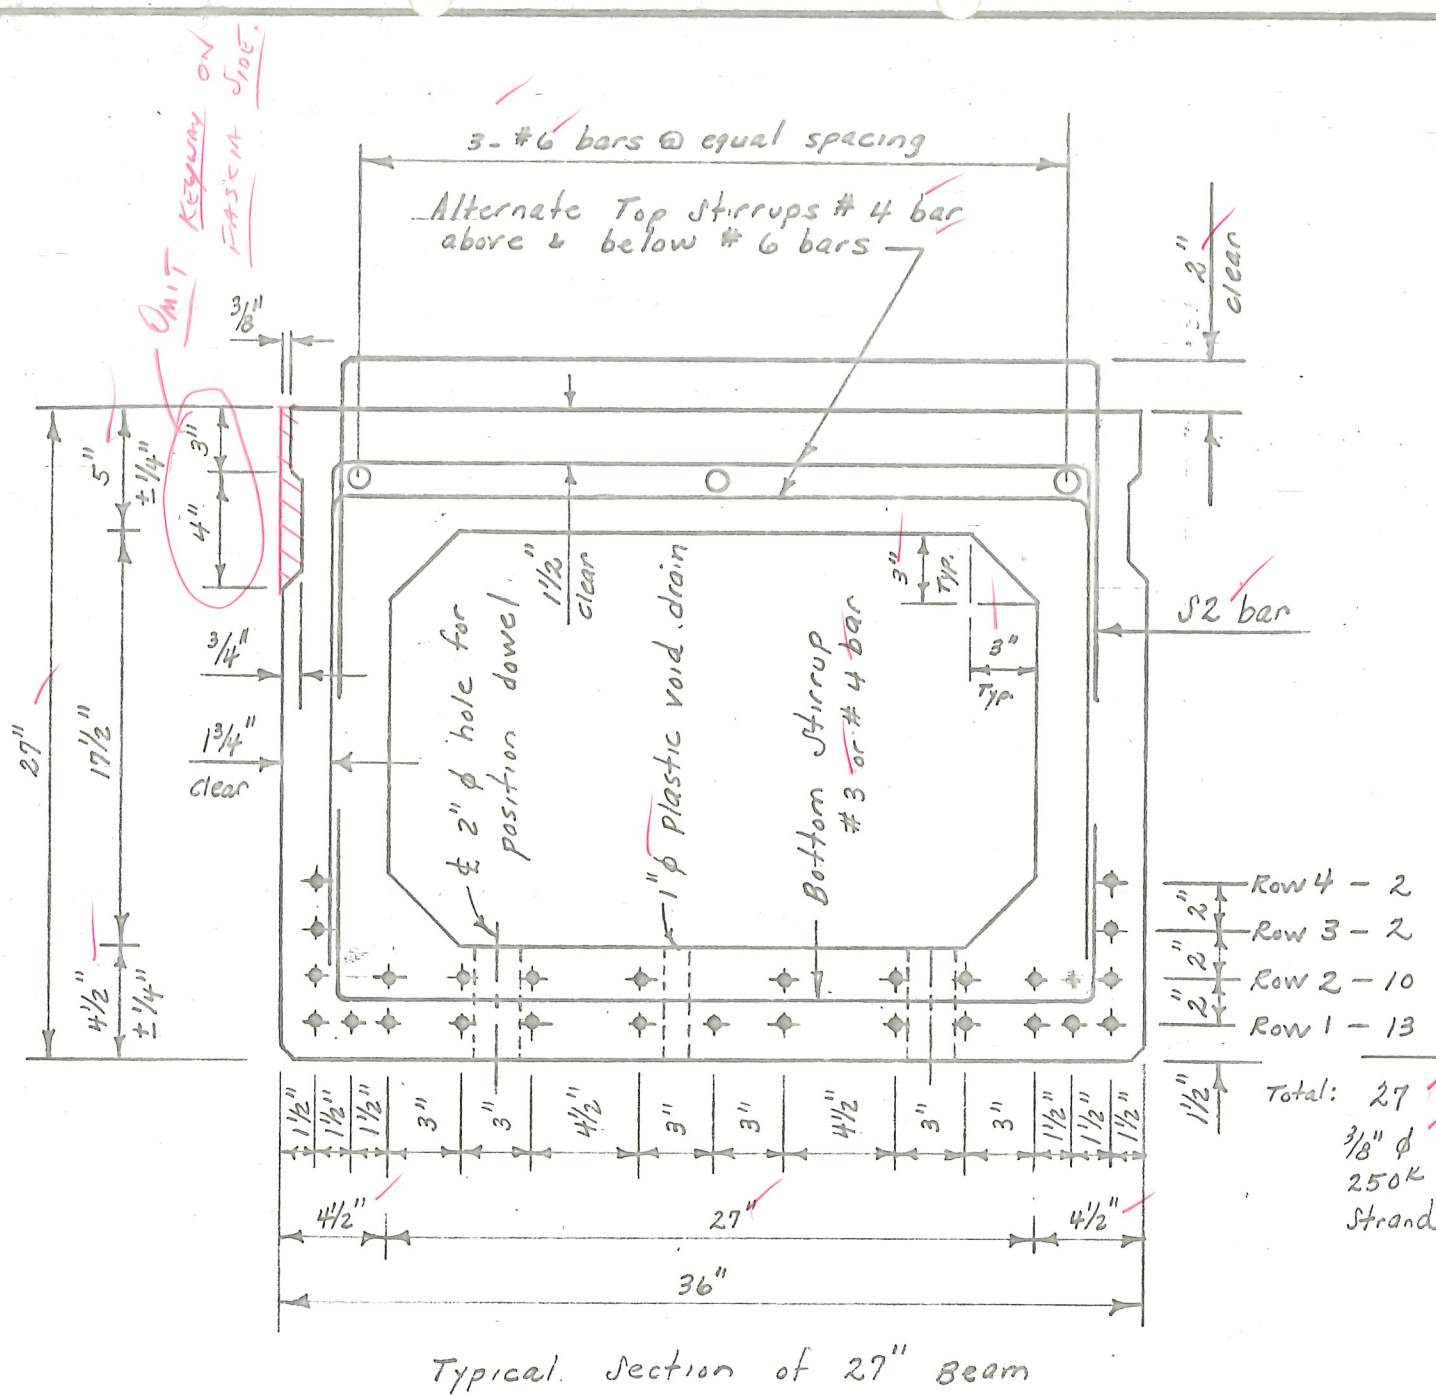
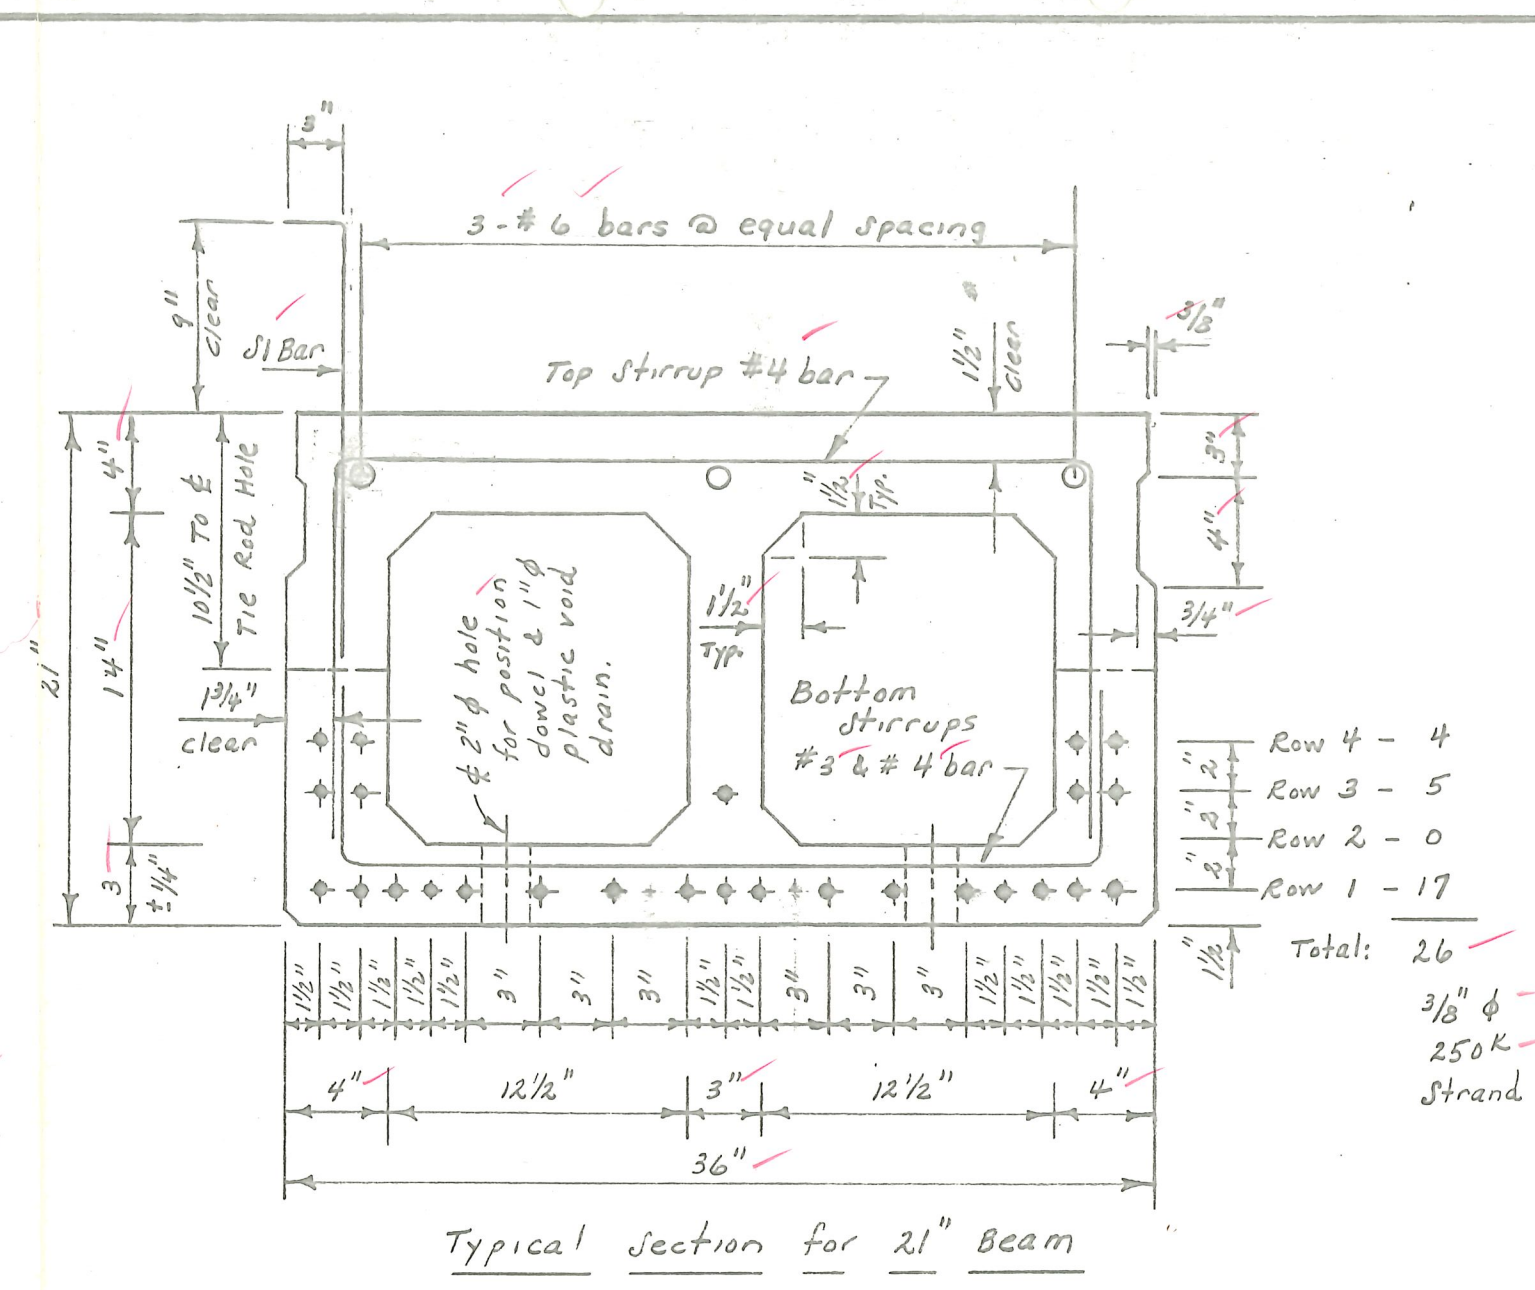
Attachment 1 - Box Beam Shop Drawing Excerpt

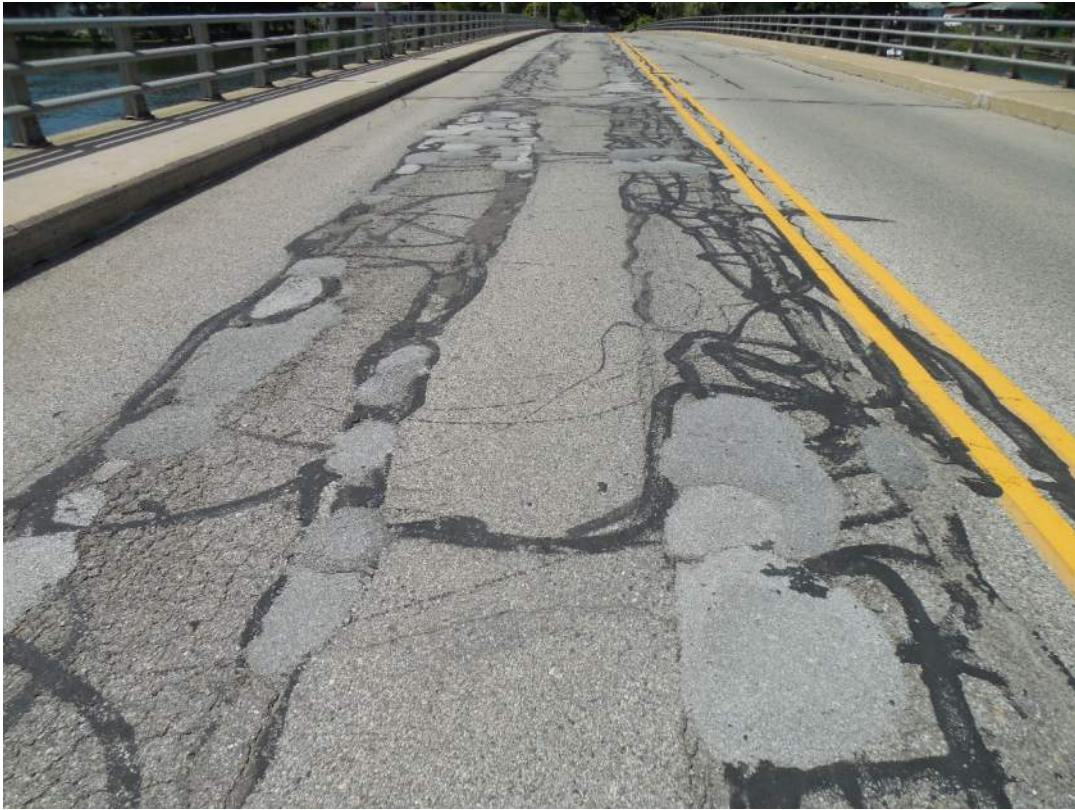
Alligator cracking, spalling and cold patch in northbound wheel lines, north half of structure

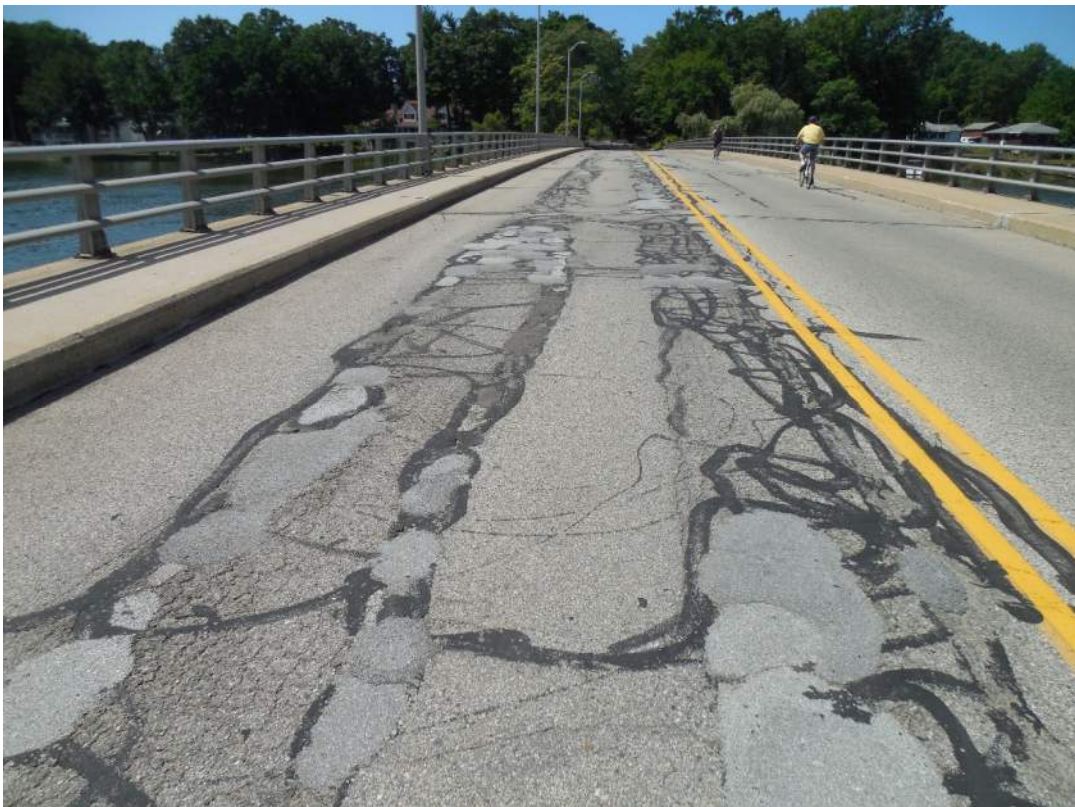
Alligator cracking, spalling and cold patch in northbound wheel lines, north half of structure

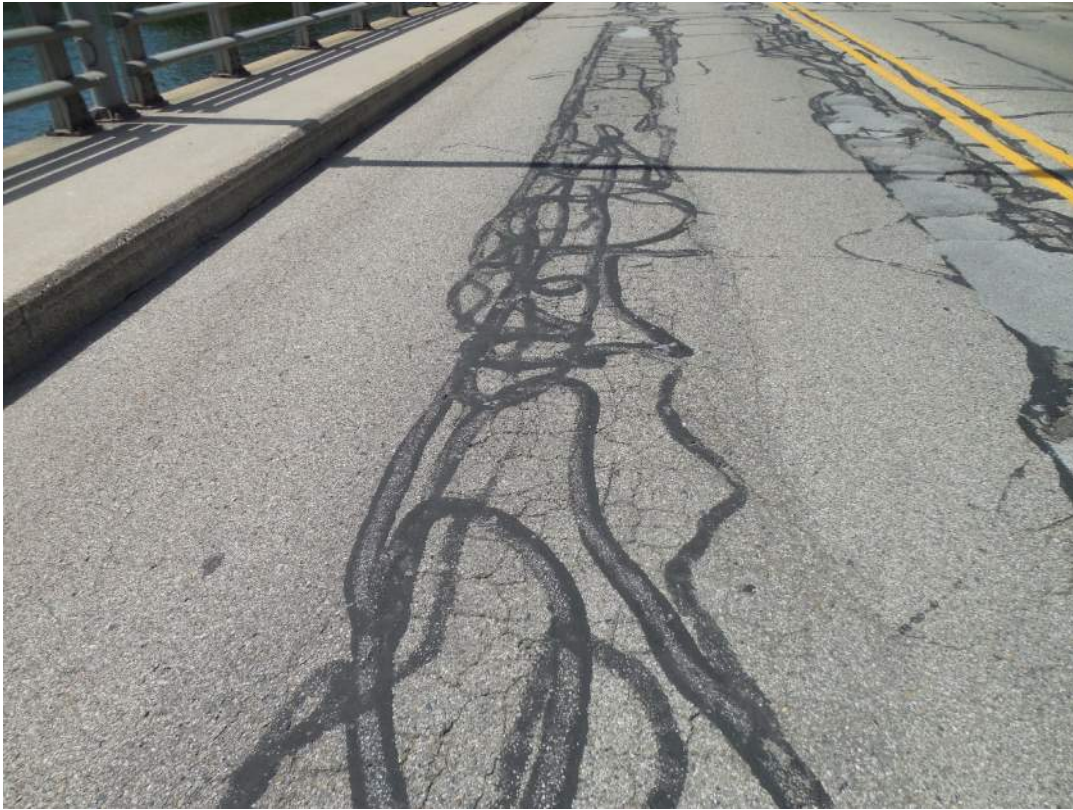
Partially sealed alligator cracking in northbound wheel line, south half of structure, looking south

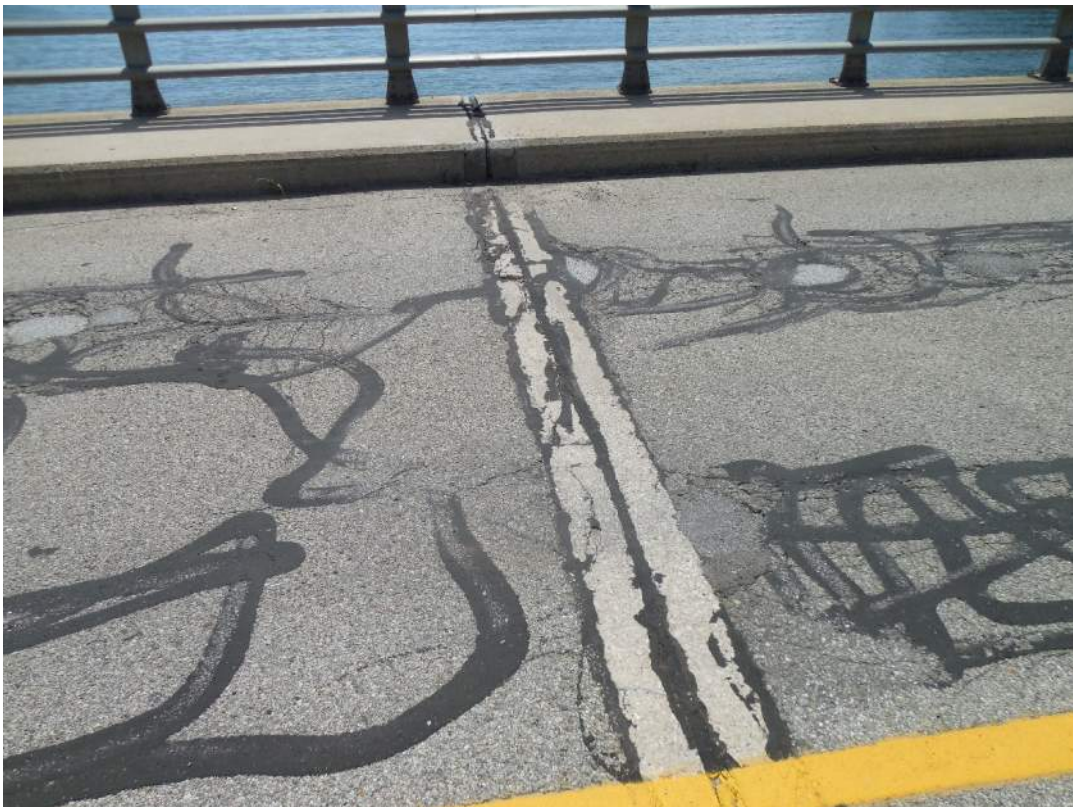
View of expansion joint in northbound lane, south half of structure, looking east

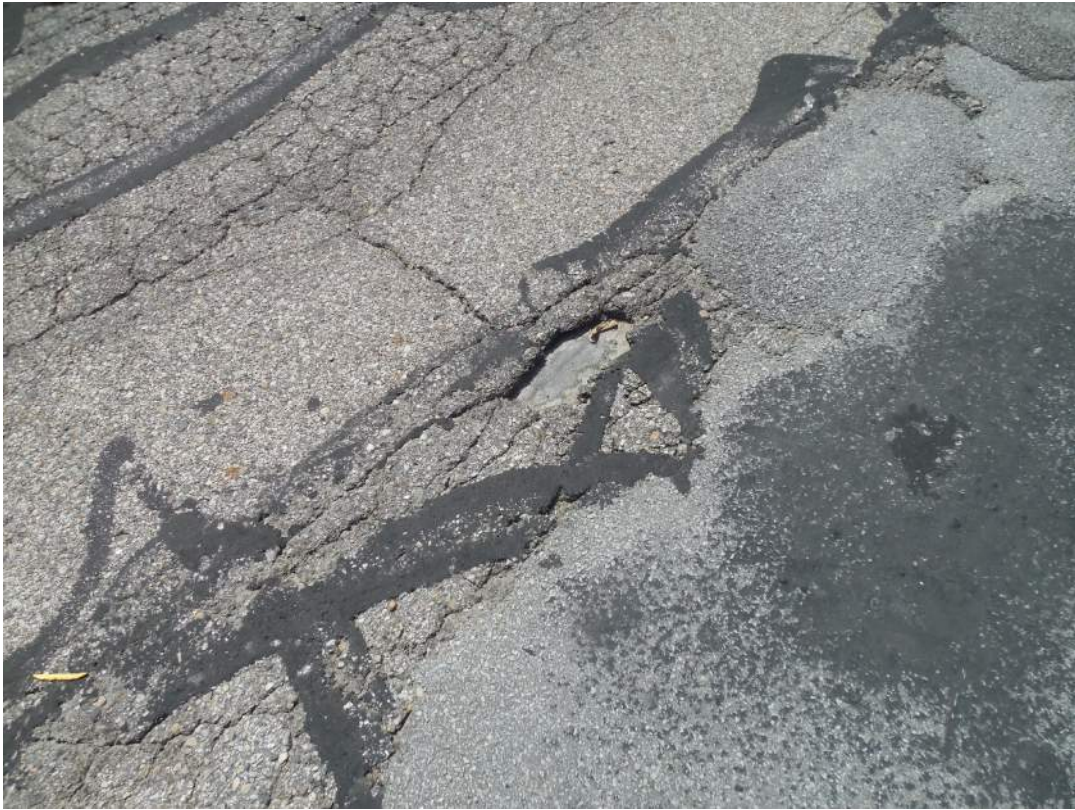
Spalling in asphalt wearing surface with exposed waterproofing membrane

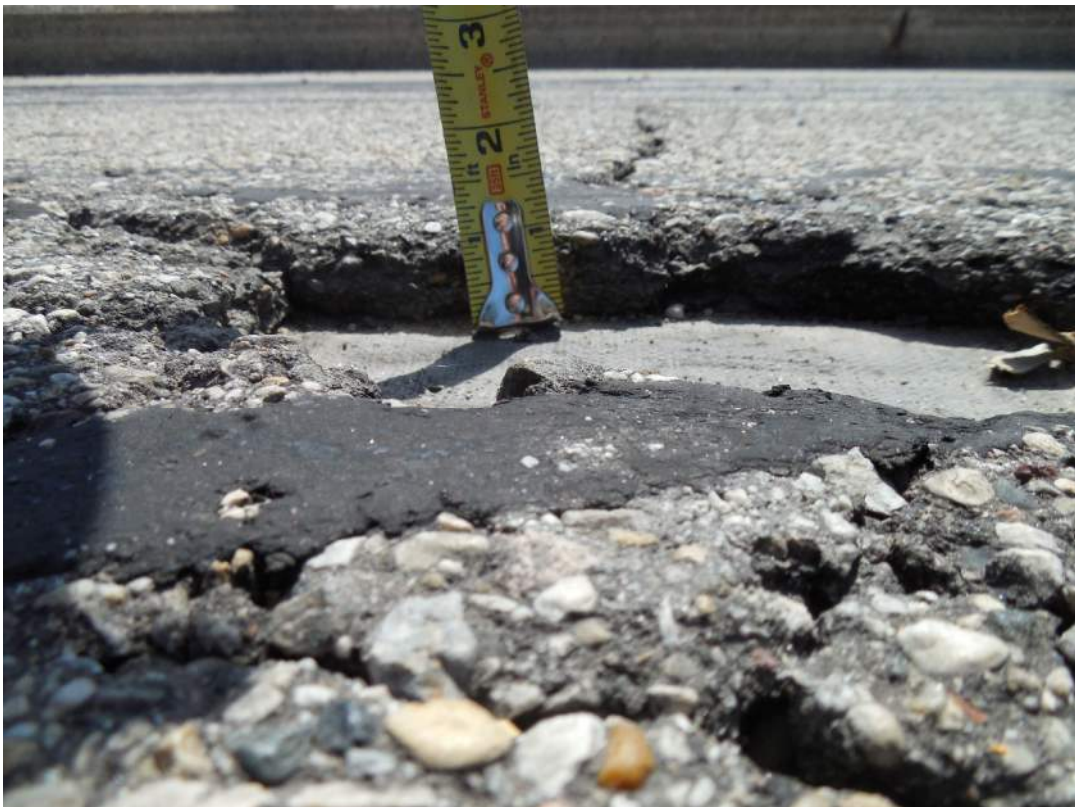
Photo illustrating thickness of asphalt, approximately 1 inch

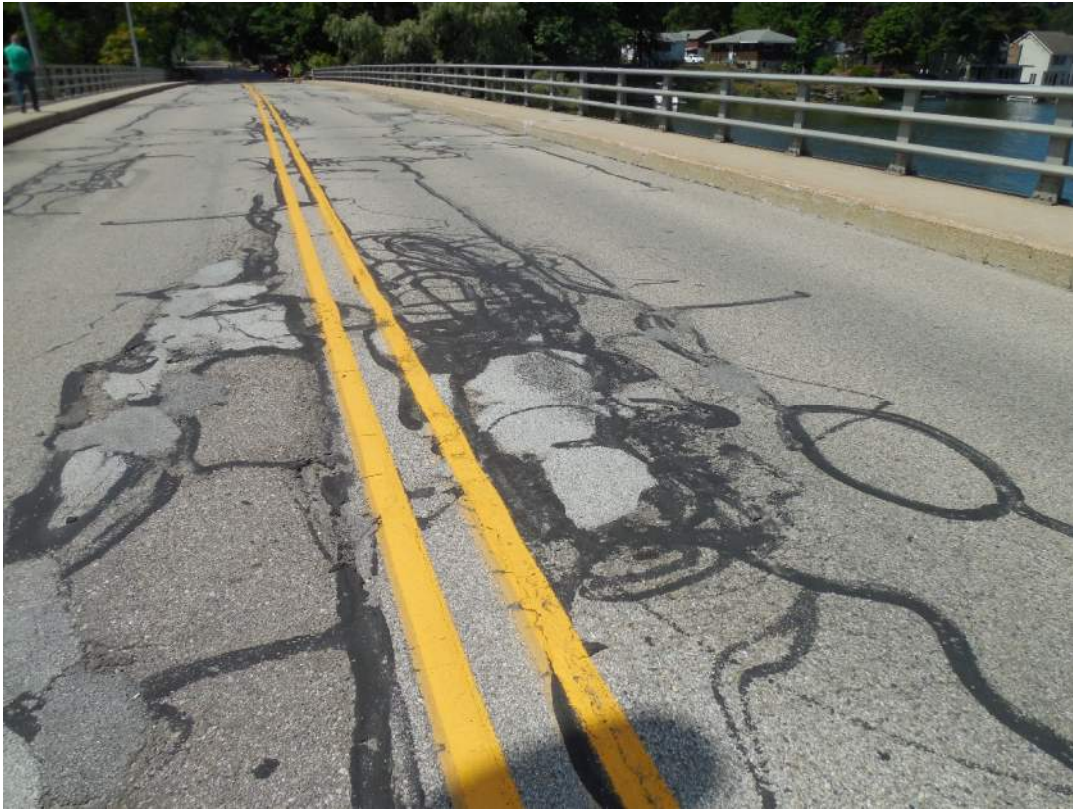
Alligator cracking, spalling and cold patch in southbound lane near center of structure, looking southwest

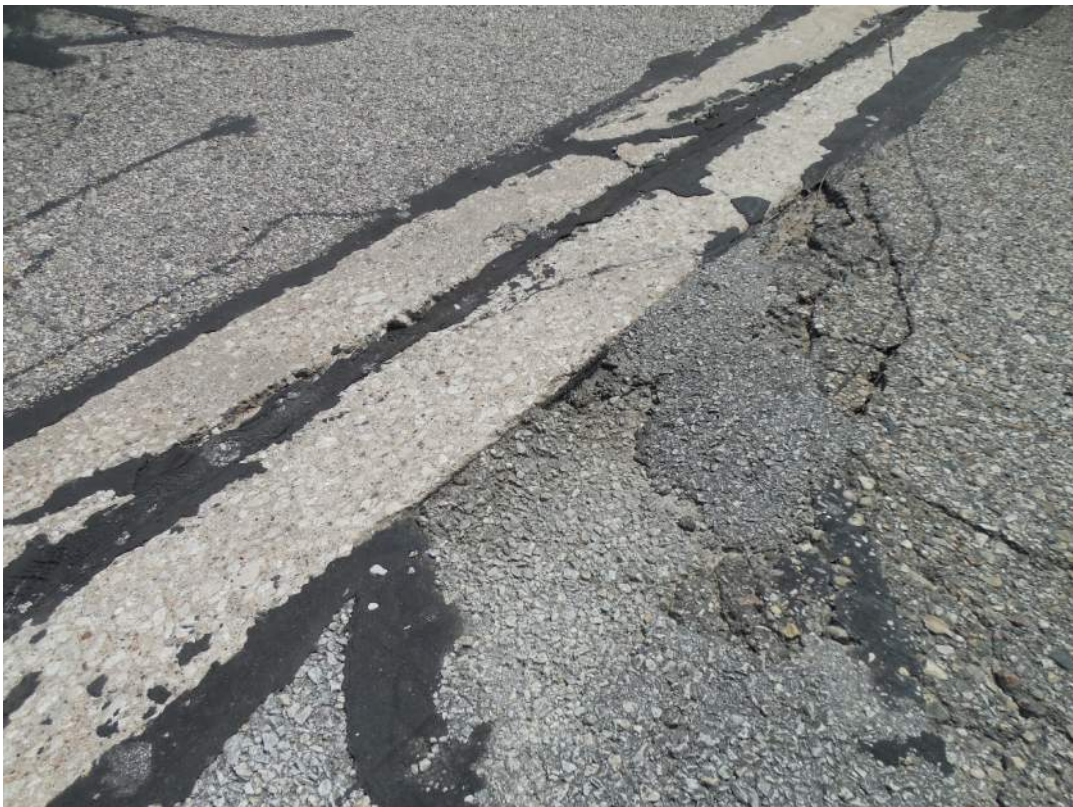
Spalling along expansion joint header and deteriorating joint seal

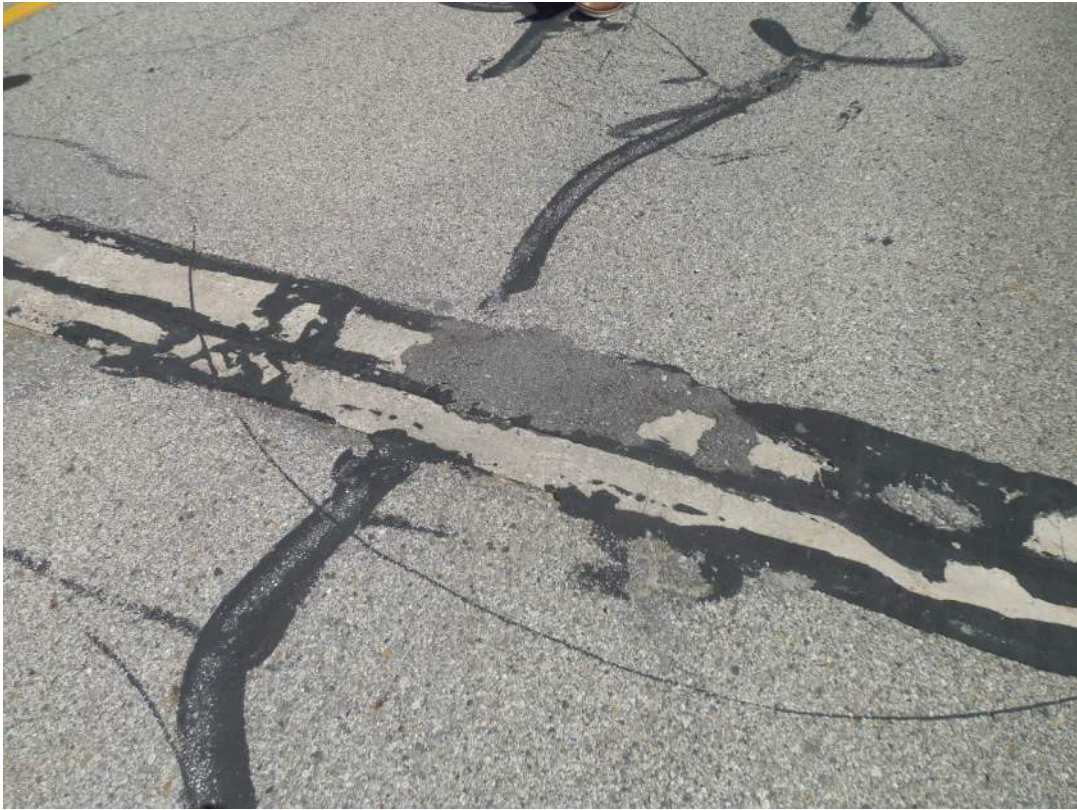
Cold patch on expansion joint header

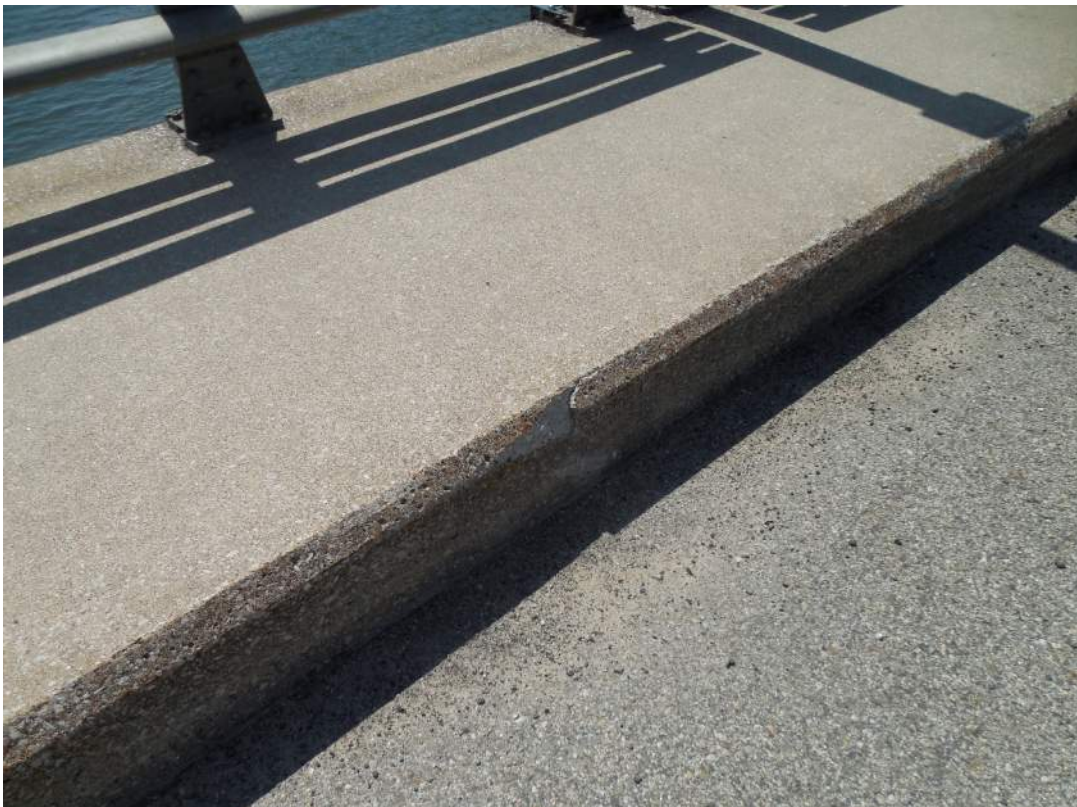
Shallow delamination and edge spalling on east sidewalk

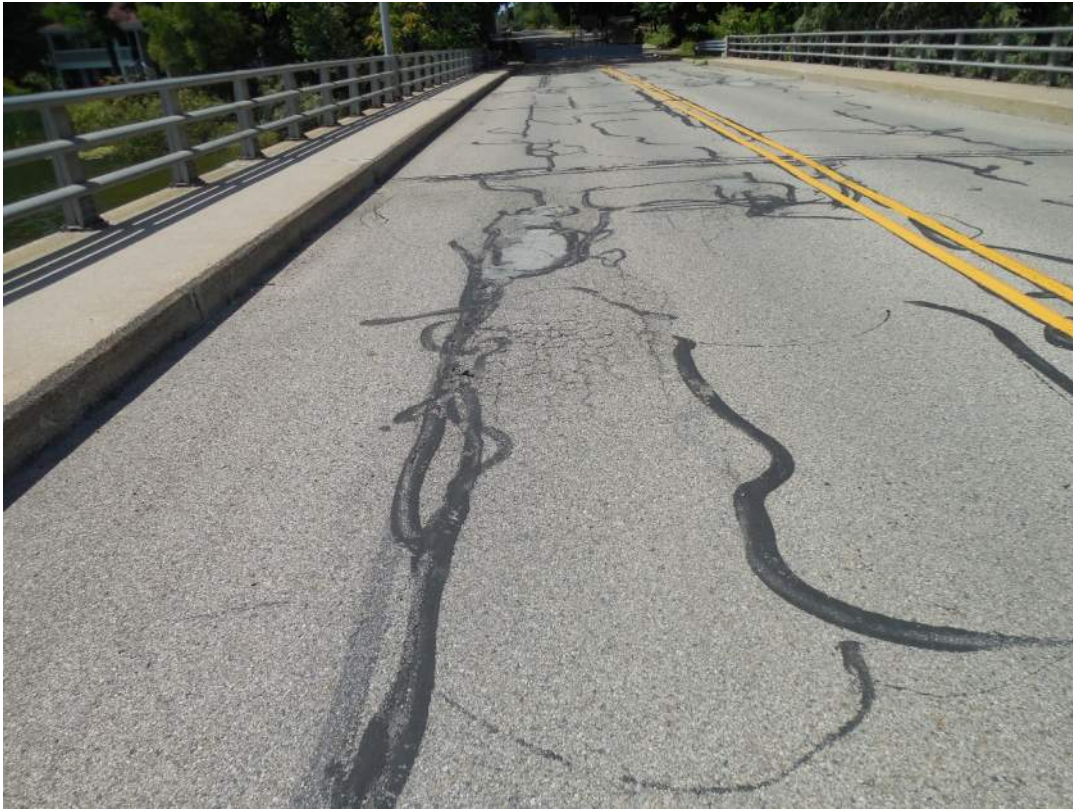
Partially sealed alligator cracking and cold patch in northbound lane, south half of structure, looking south

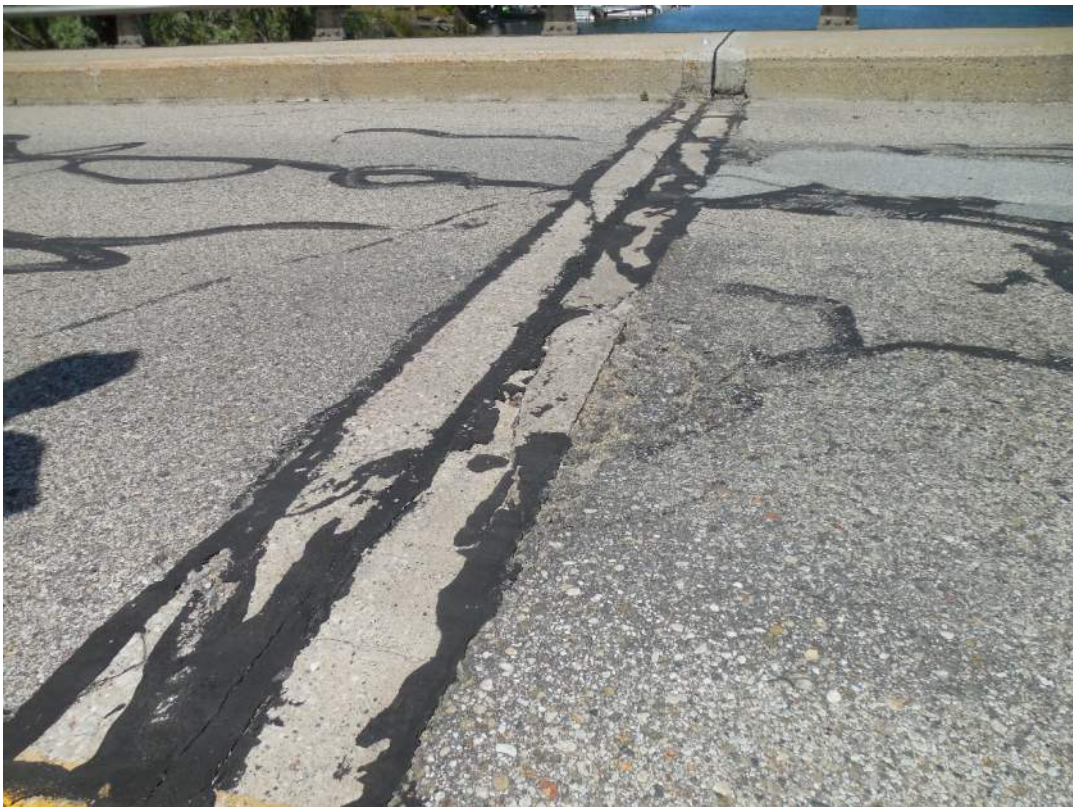
Spalling on expansion joint header in southbound lane

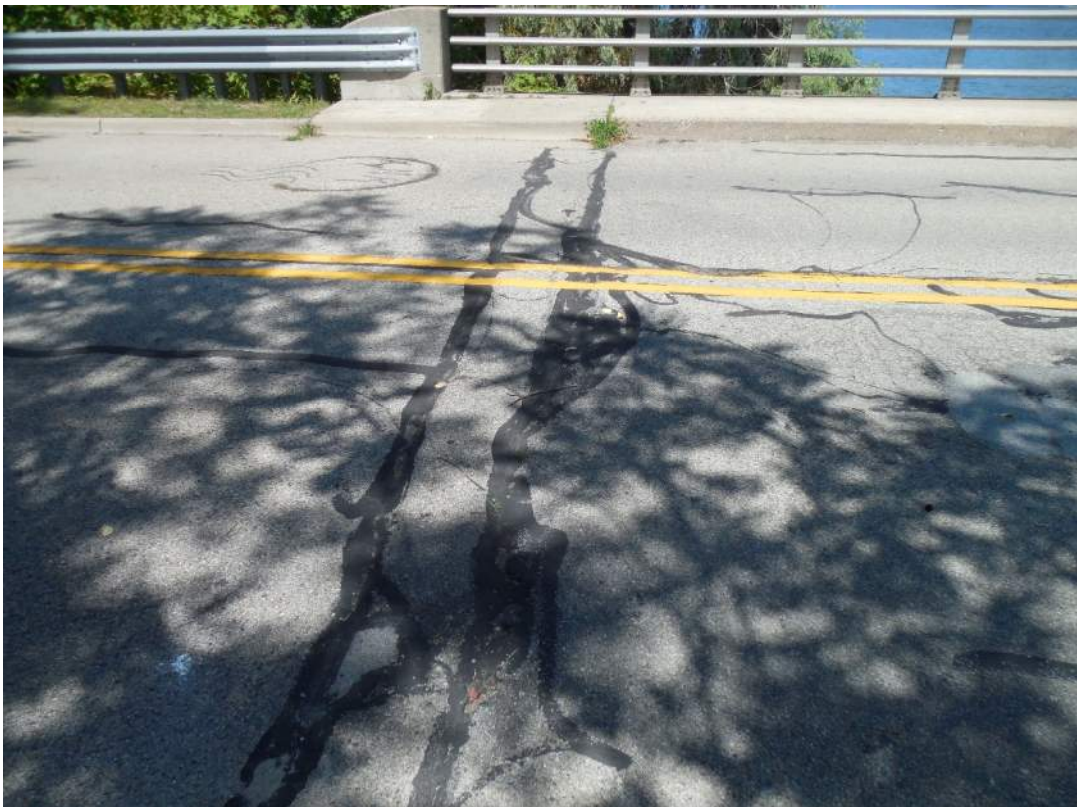
Sealed transverse cracking at south abutment, looking west

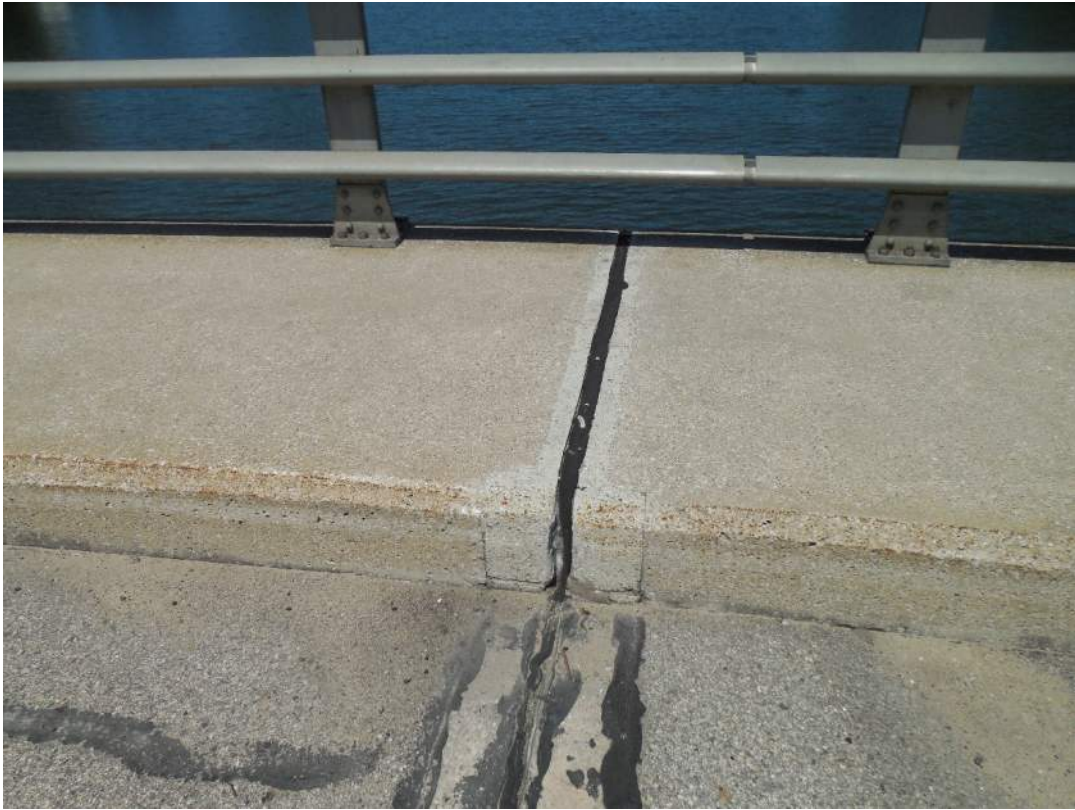
Deteriorating joint seal on sidewalk

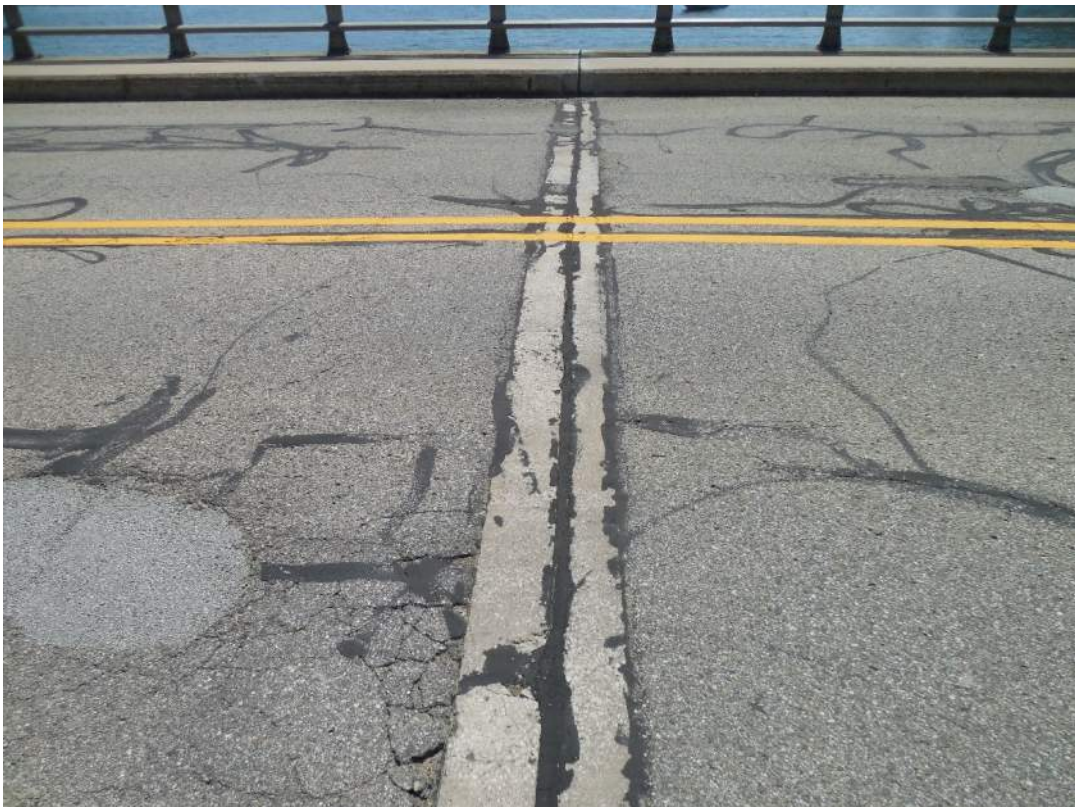
View of expansion joint looking east

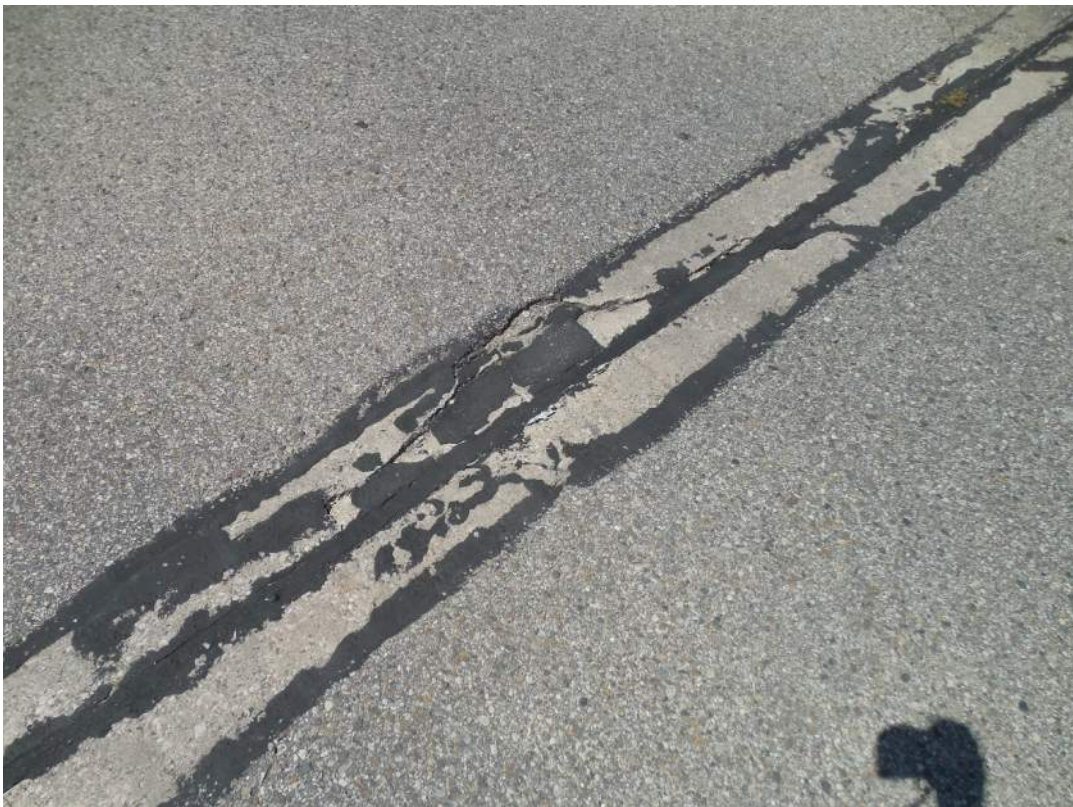
Spalling on expansion joint header

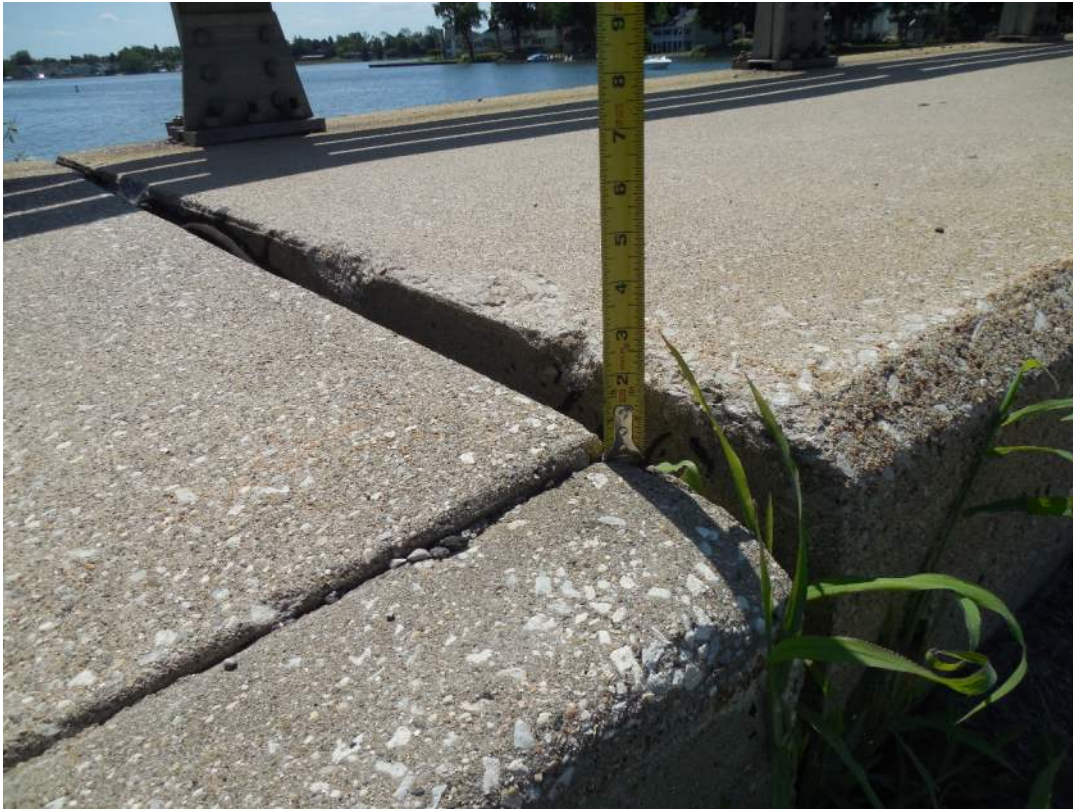
Photo illustrating settlement of northeast approach sidewalk, approximately 2 inches

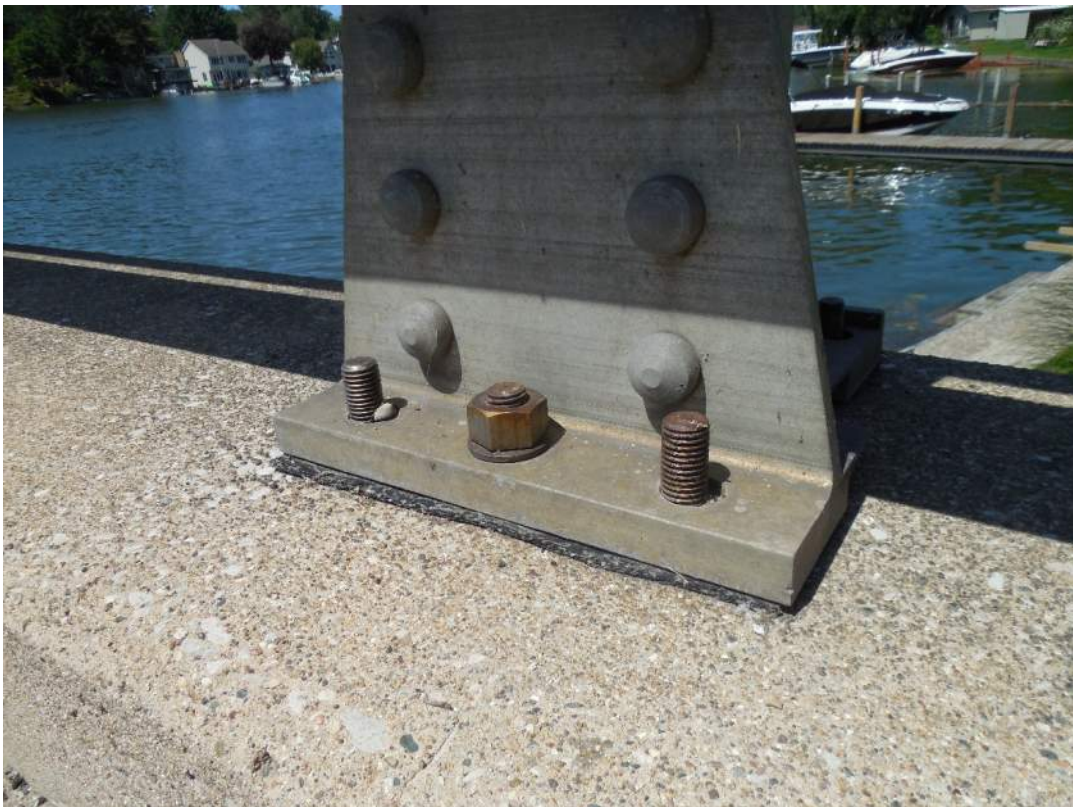
Missing hardware on northwest railing post

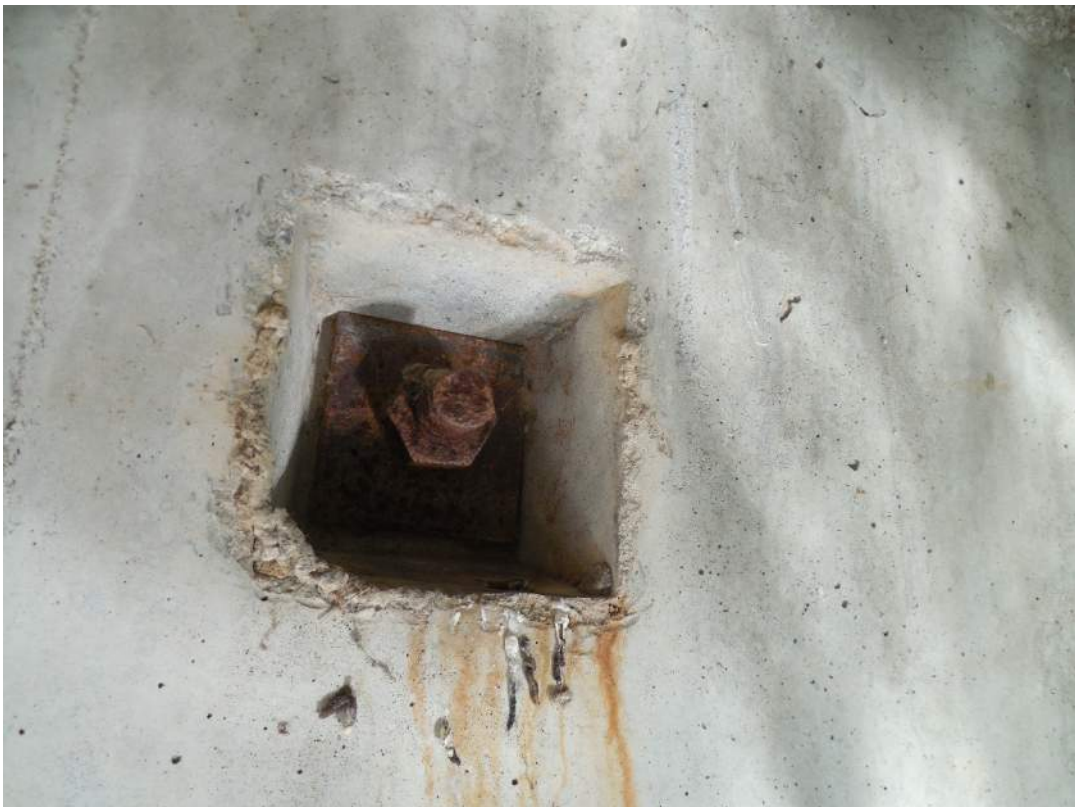
Heavy surface corrosion on post tensioning steel

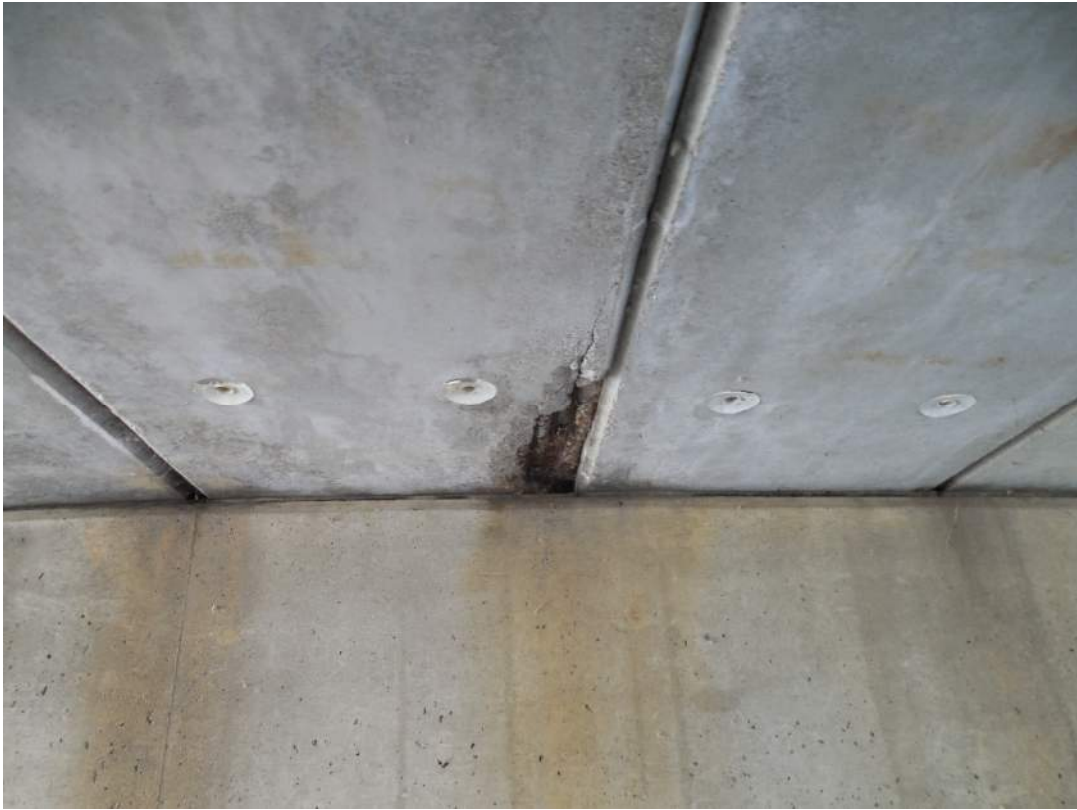
Span 8S, Beam 6W, spalling with 3 broken strands at Pier 7S

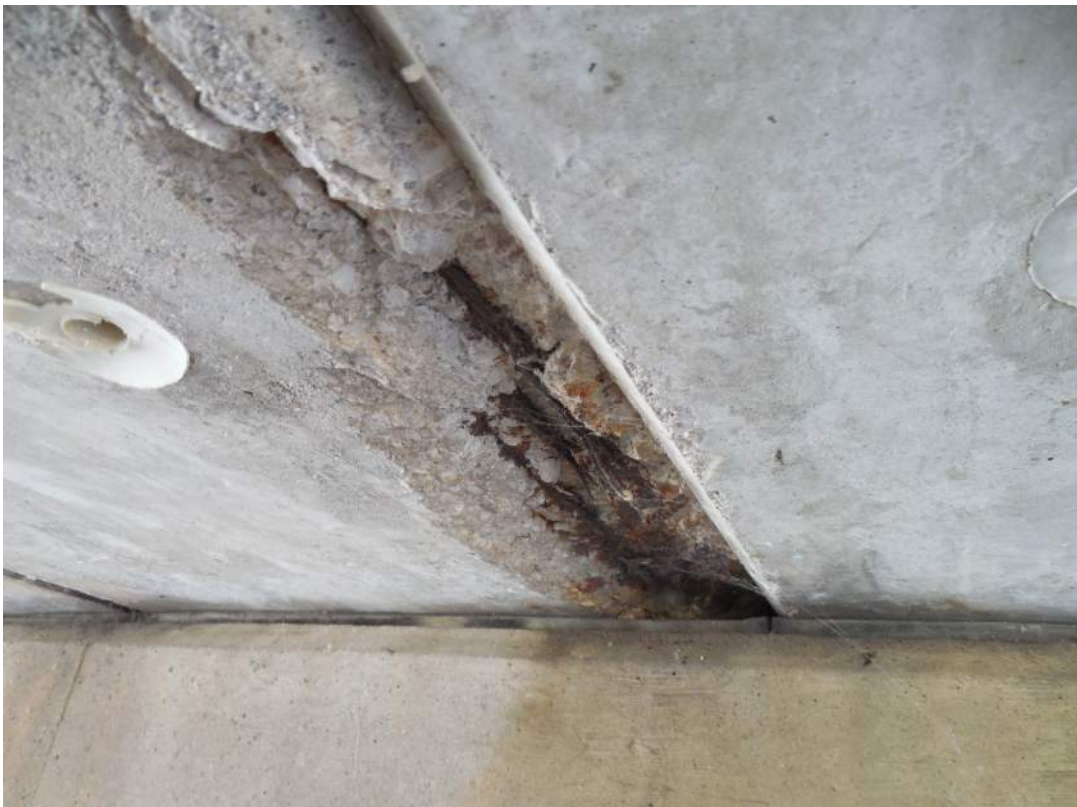
Close-up of spalling at Span 8S, Beam 6W, Pier 7S
