August 30, 2019

Mr. Craig Bessinger, City Manager
City of Ferrysburg
17290 Roosevelt Road
PO Box 38
Ferrysburg, MI 49409-0038

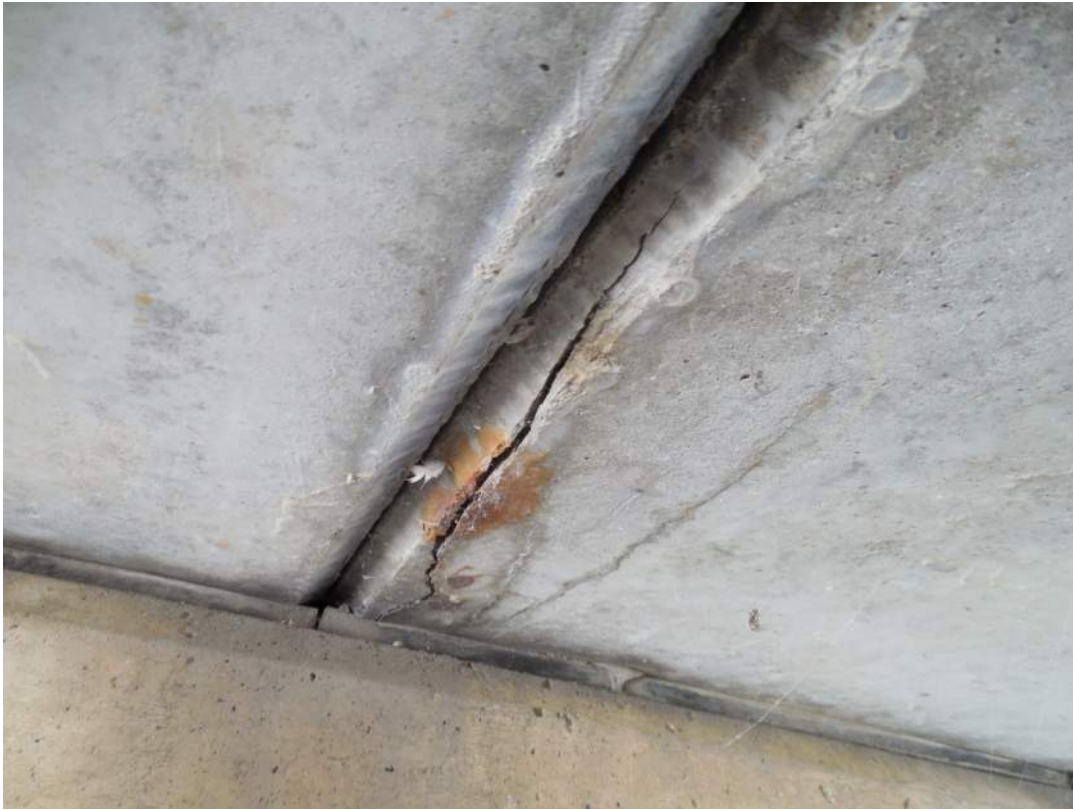
Span 8S, Beam 3W, cracking and delamination at Pier 7S

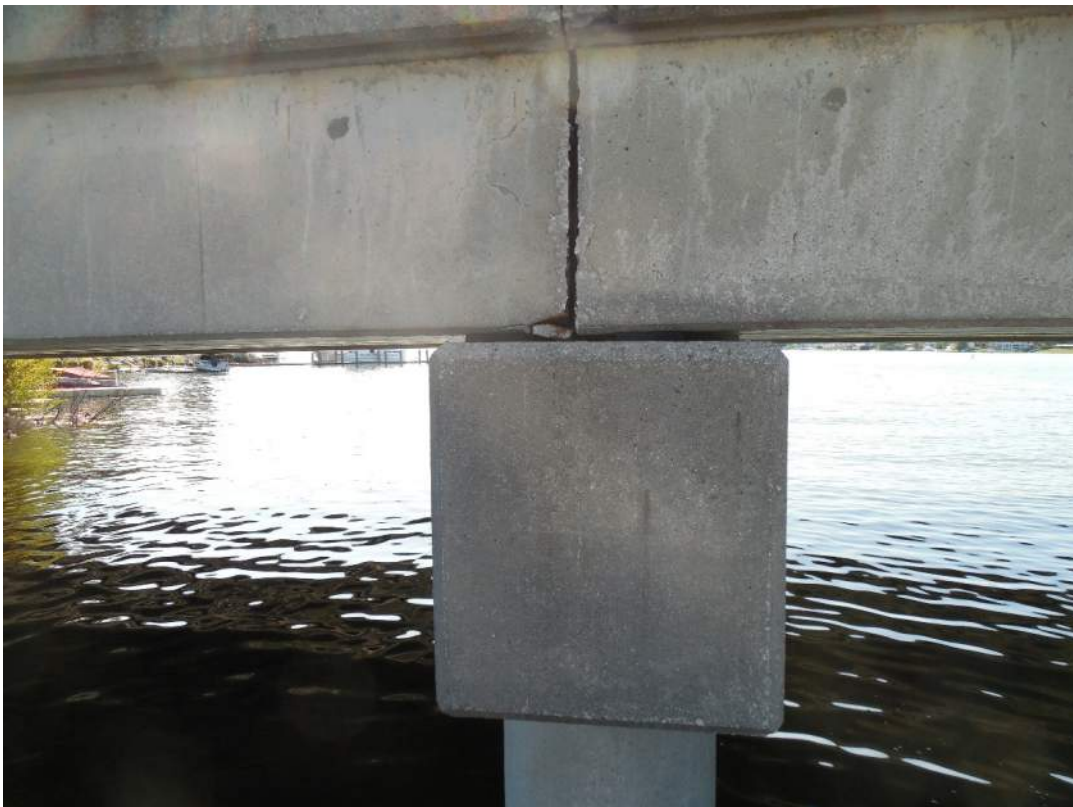
Corner spalling on Beam 1W, Span 8S at Pier 7S

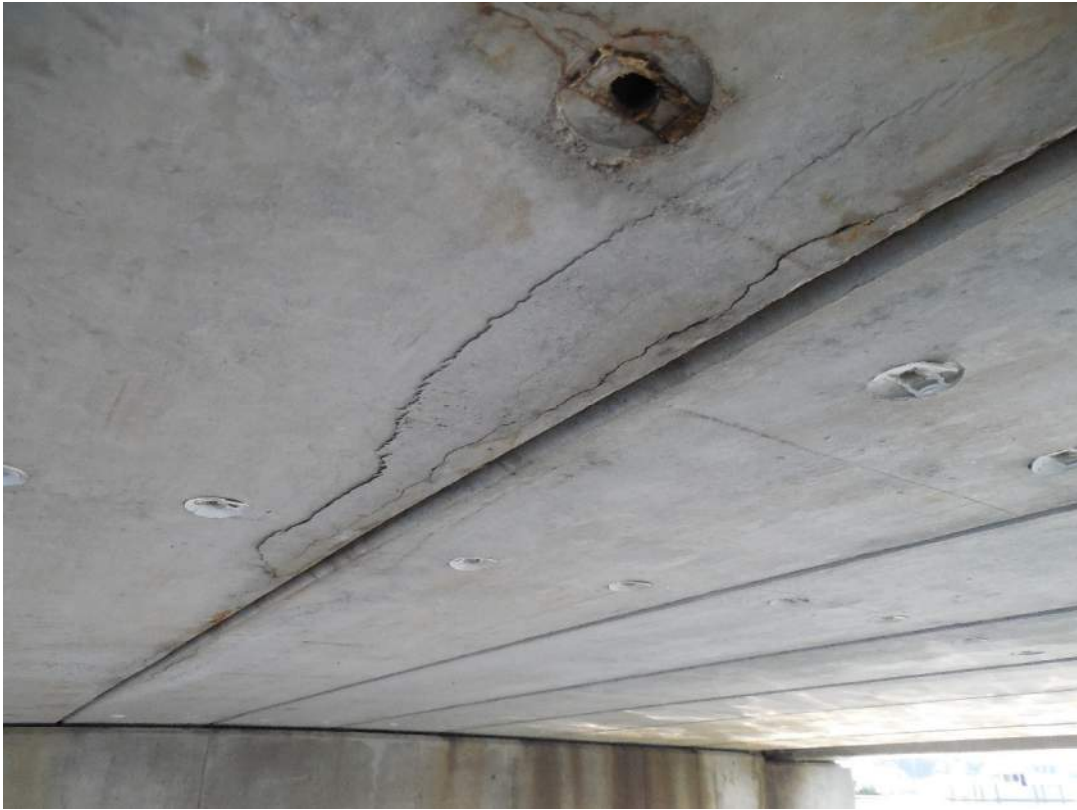
Span 7S, Beam 5W, cracking and delamination north of midspan

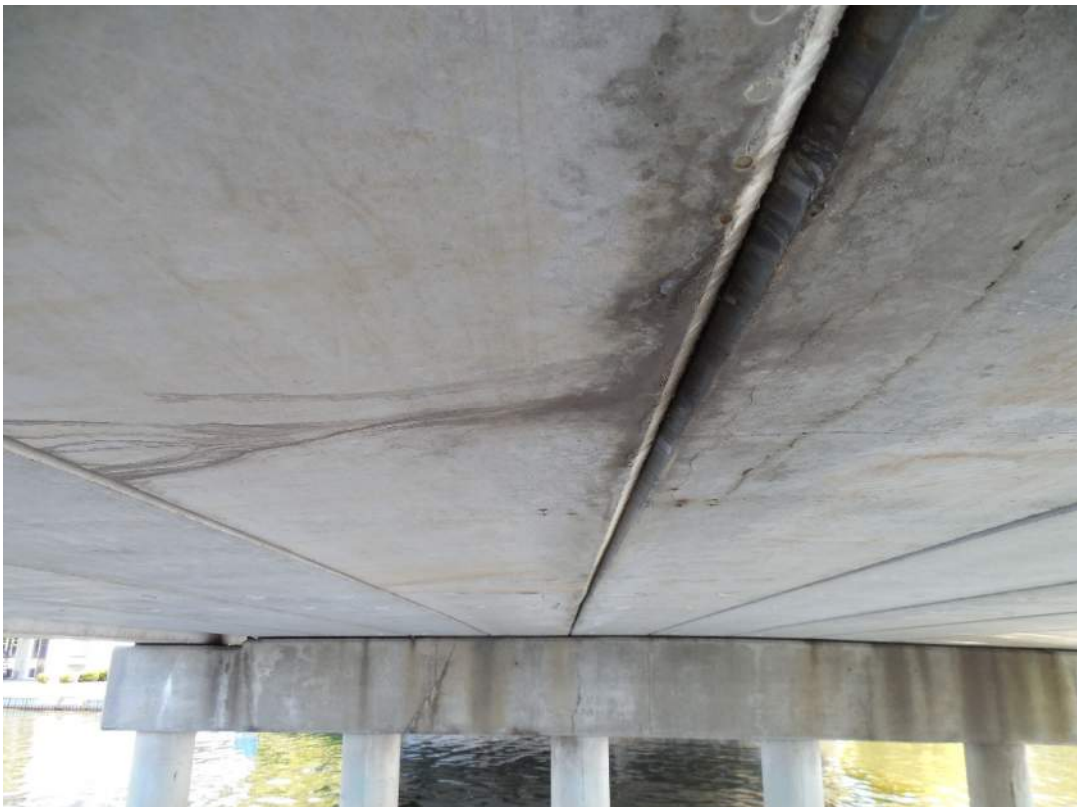
Span 7S, evidence of leakage between Beams 5W and 6W and cracking on 6W near midspan

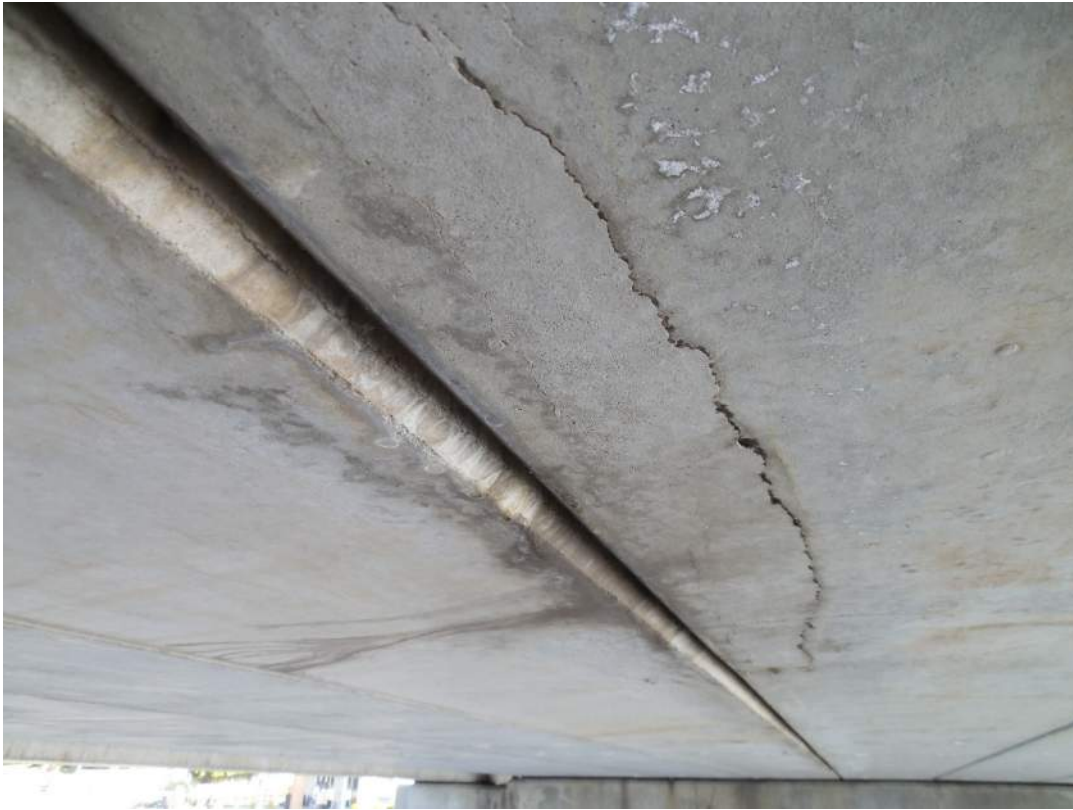
Span 7S, Beam 6W, cracking and delamination near midspan

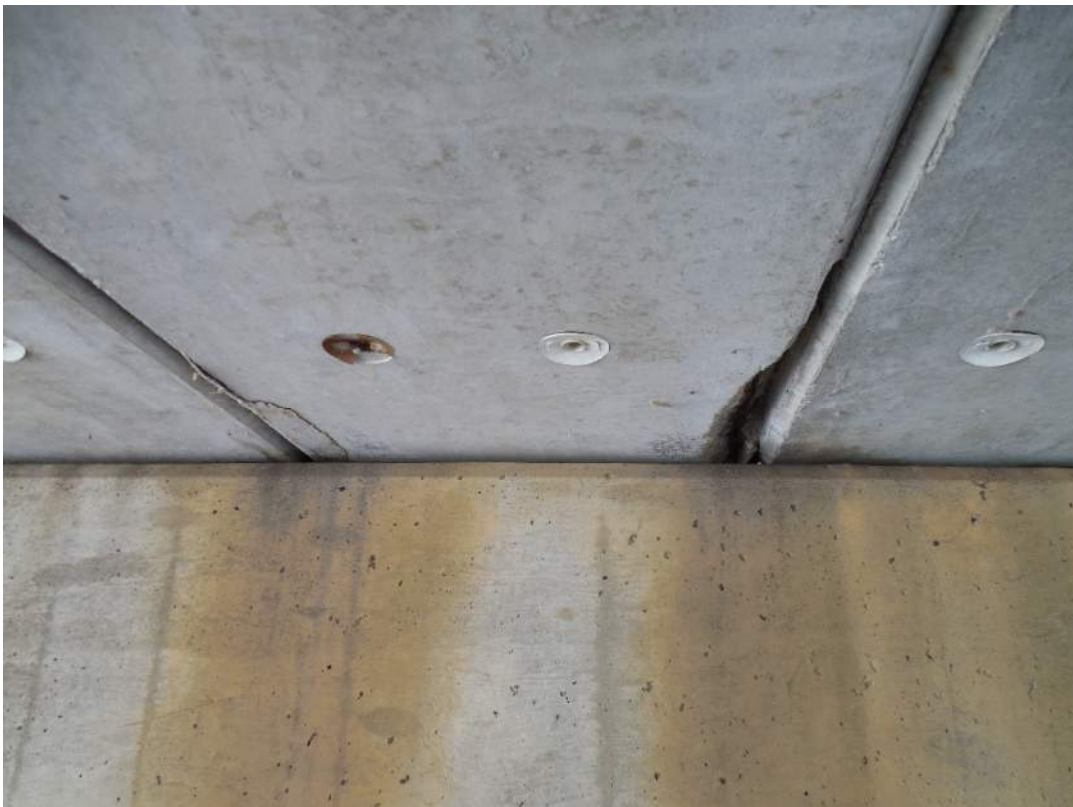
Span 7S, Beam 5W, spalling with broken strand (right) and cracking/delamination (left) at Pier 6S

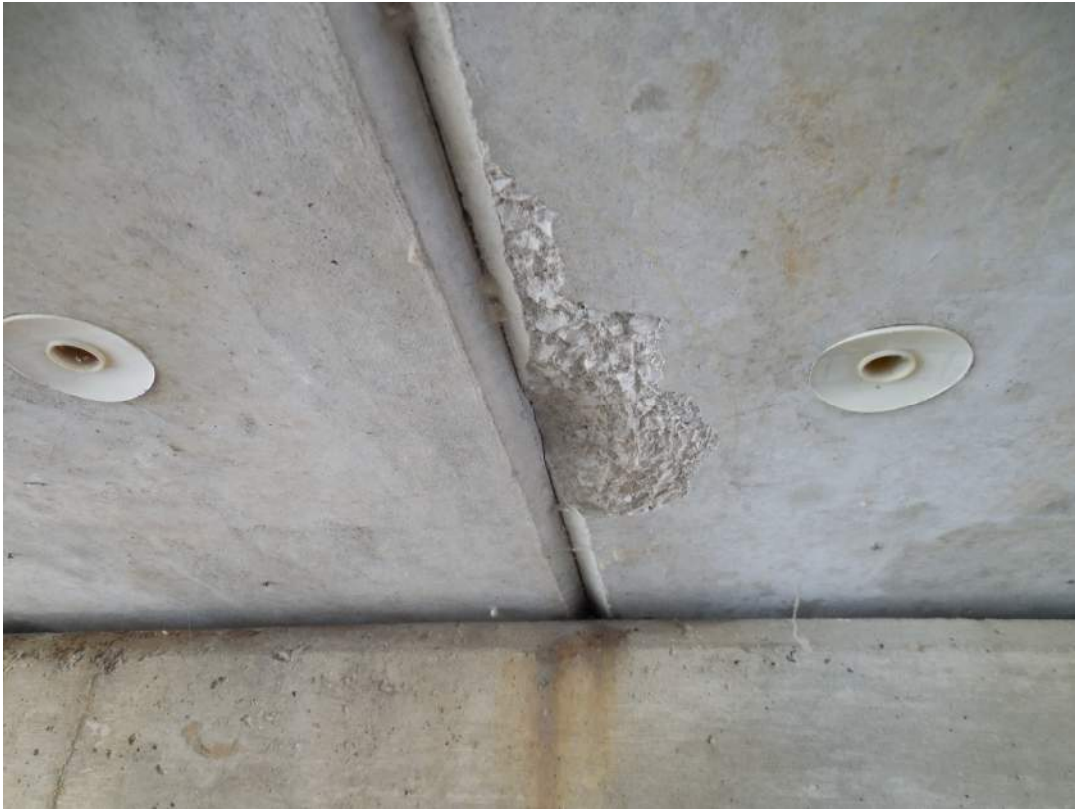
Span 7S, Beam 8W, spalling with no exposed steel near Pier 6S

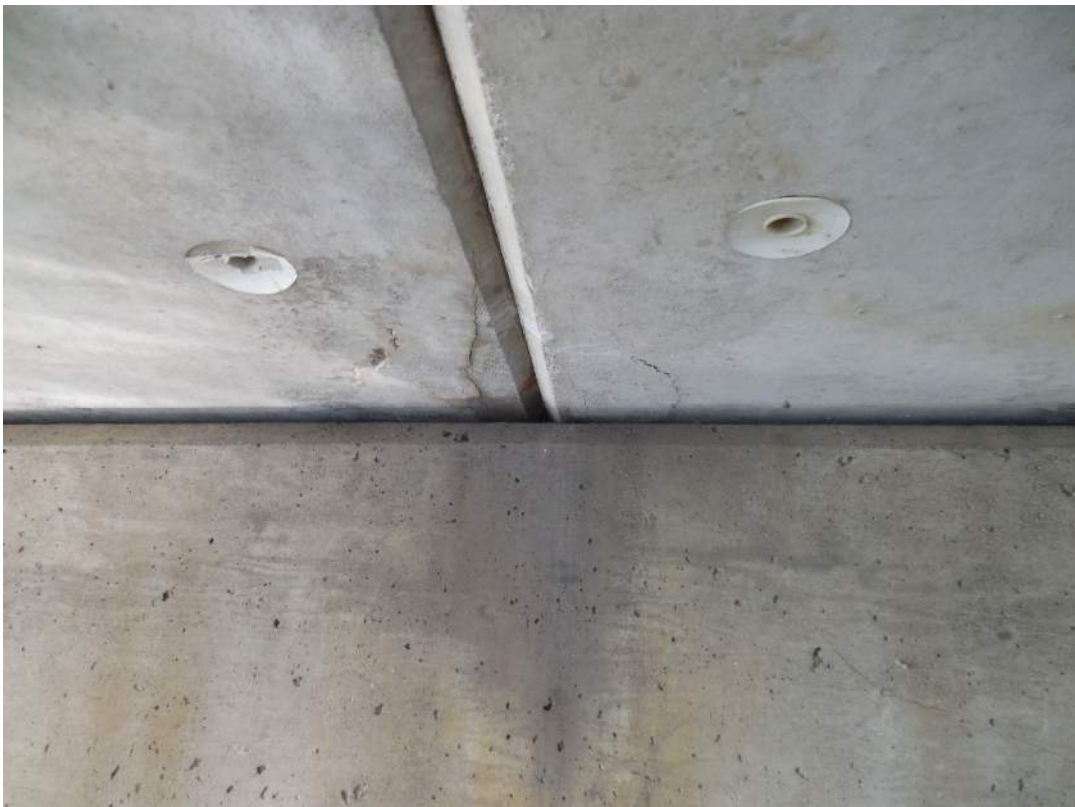
Span 7S, Beams 10W and 11W, cracking and delamination at Pier 6S

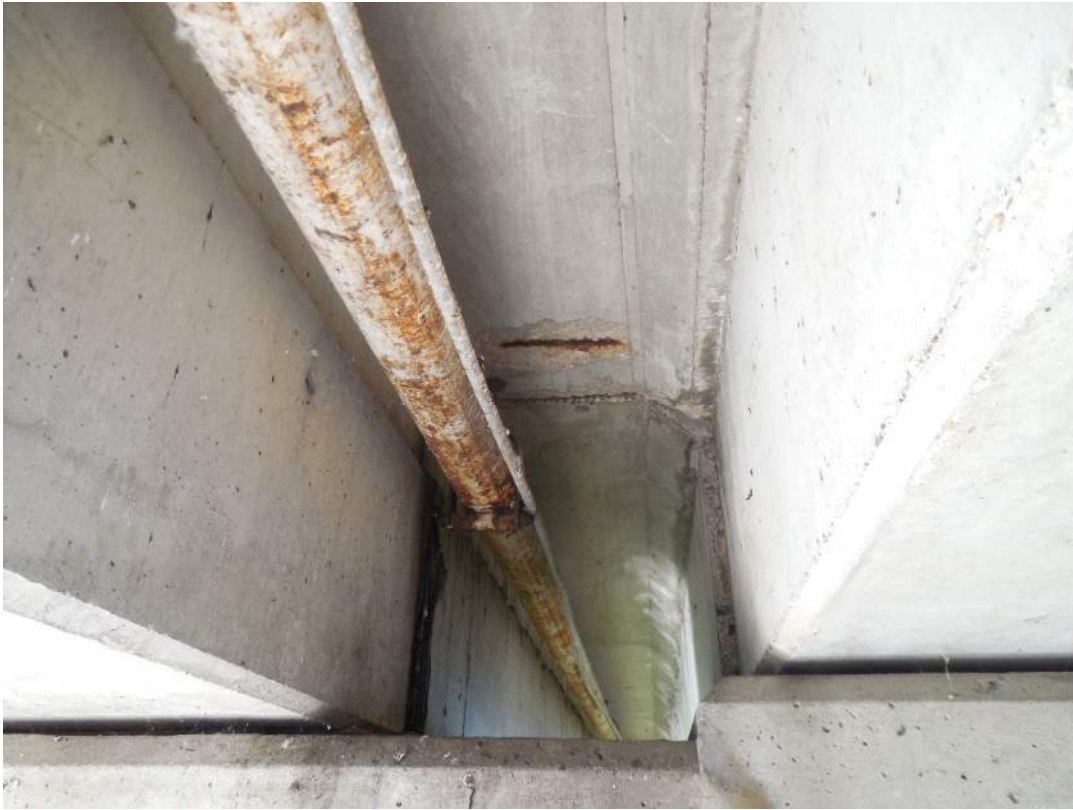
Isolated spall with exposed steel on bottom of sidewalk at Pier 6S

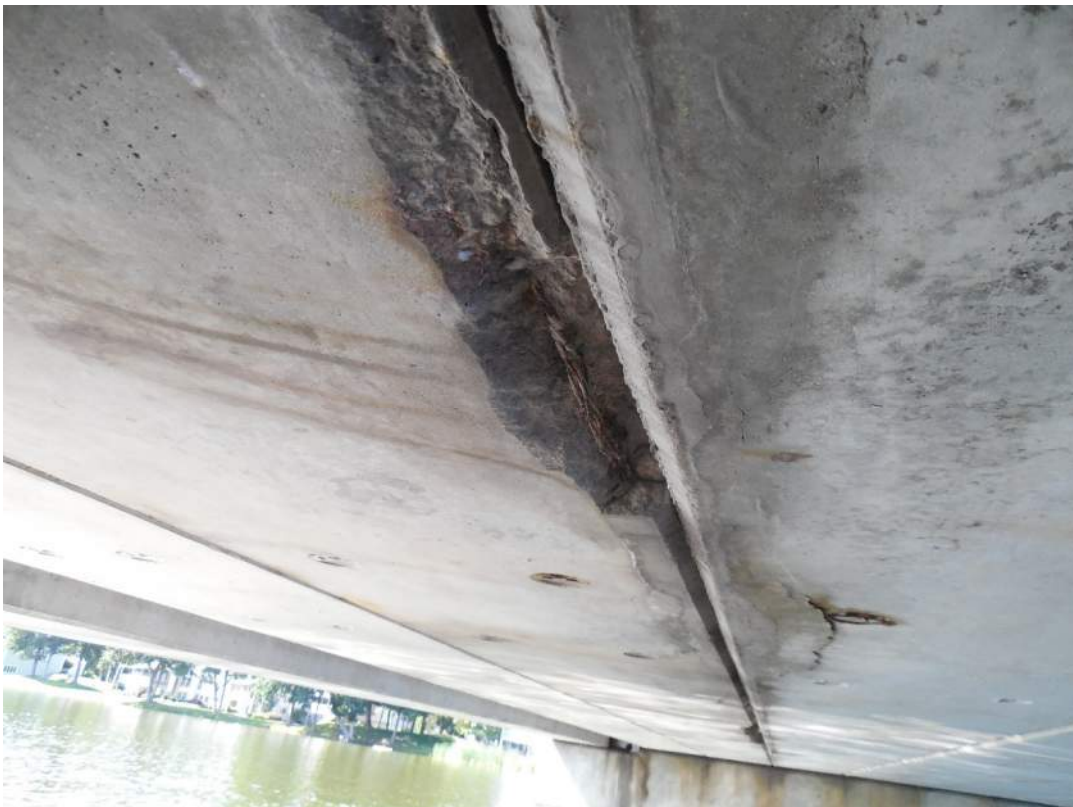
Span 6S, Beam 11W, spalling with broken strand ~15' south of Pier 6S and cracking/delamination on 10W

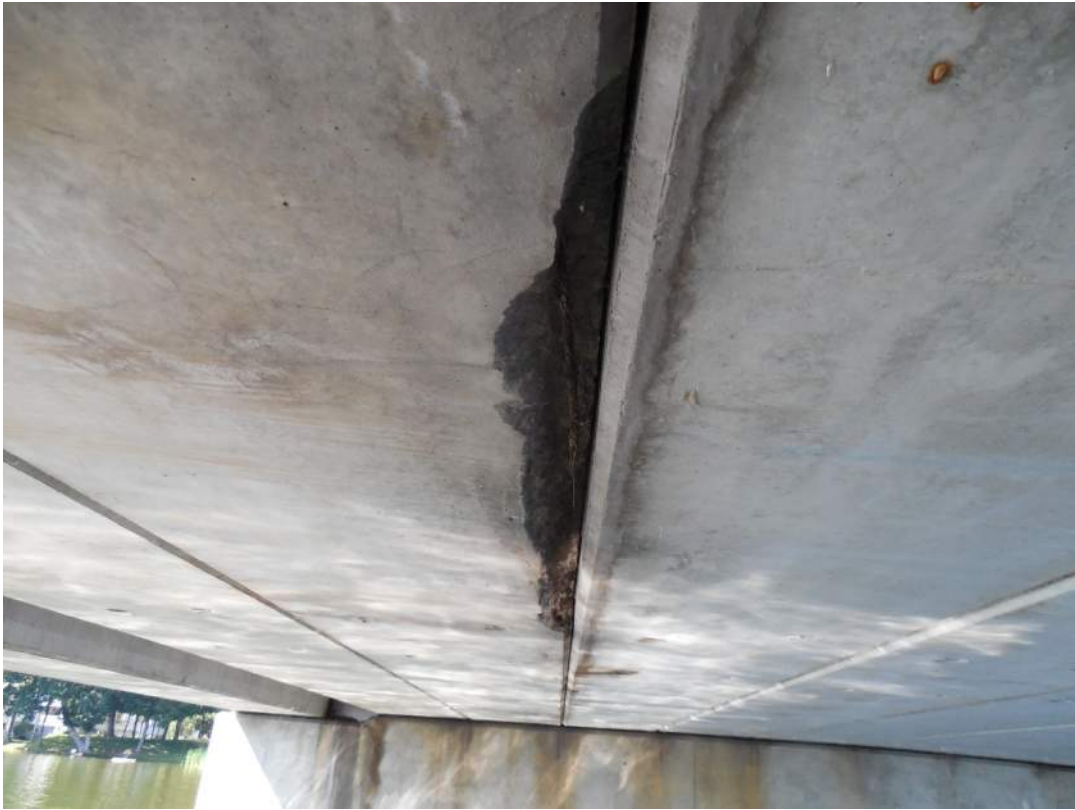
Span 6S, Beam 11W, spalling with broken strand south of midspan

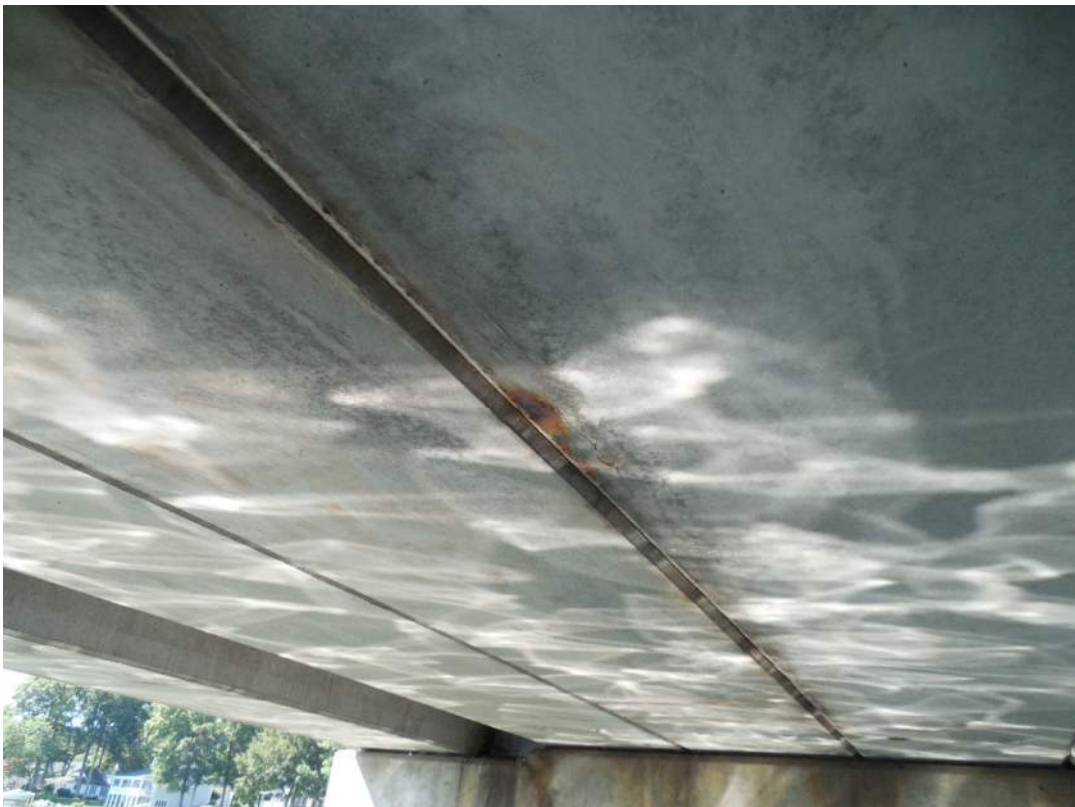
Span 6S, Beam 10W, cracking and rust staining ~15' from Pier 5S

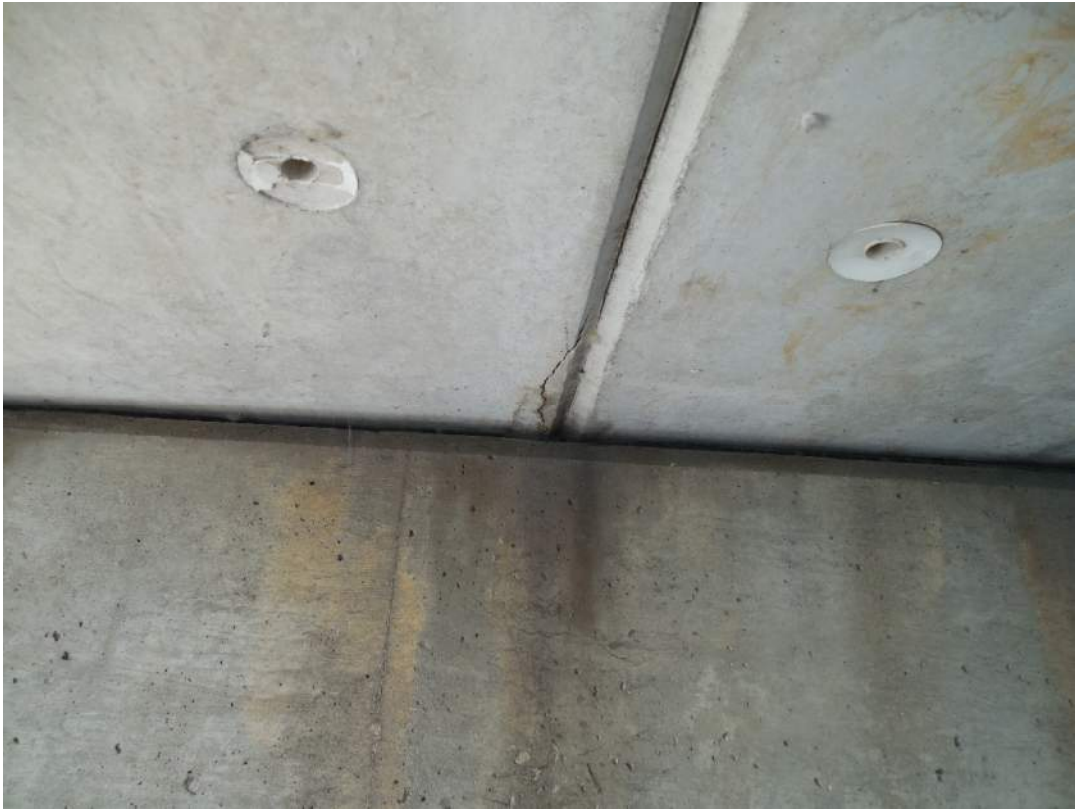
Span 6S, Beam 12W, cracking and delamination at Pier 5S

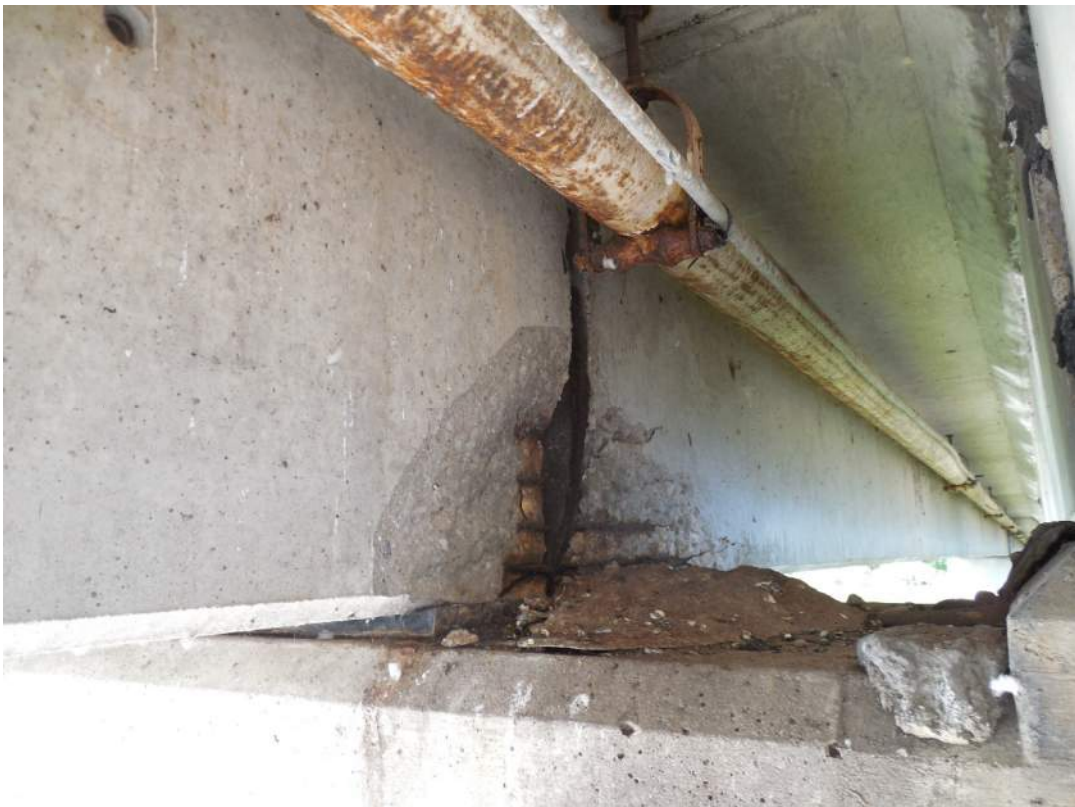
Span 6S, Beam 13W, spalling with exposed steel on inside face at Pier 5S

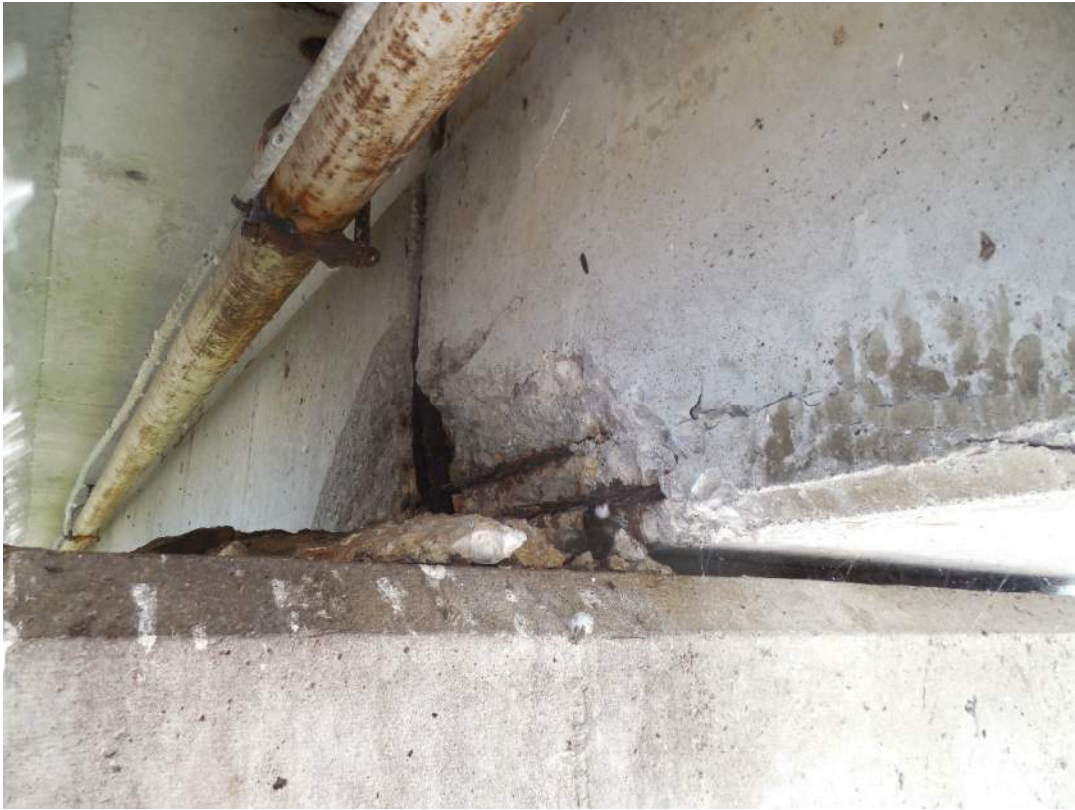
Span 5S, Beam 13W, spalling with exposed steel on interior face at Pier 5S

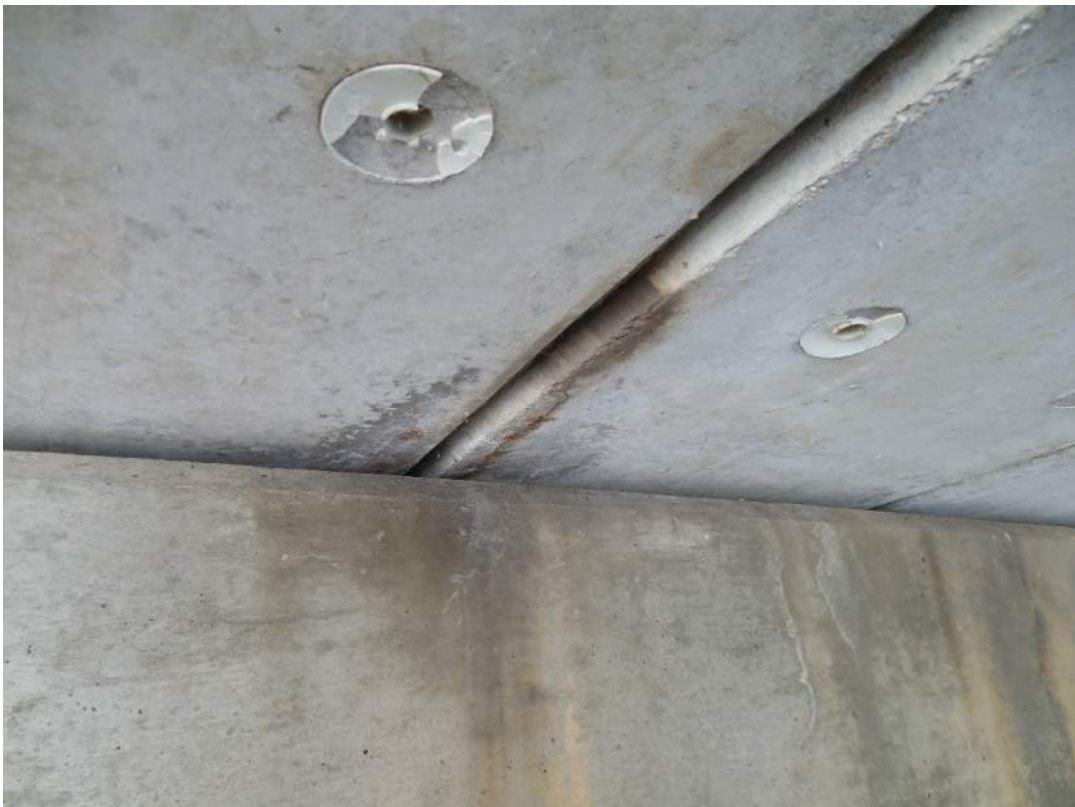
Span 3S, Beam 5W, cracking and delamination at Pier 2S

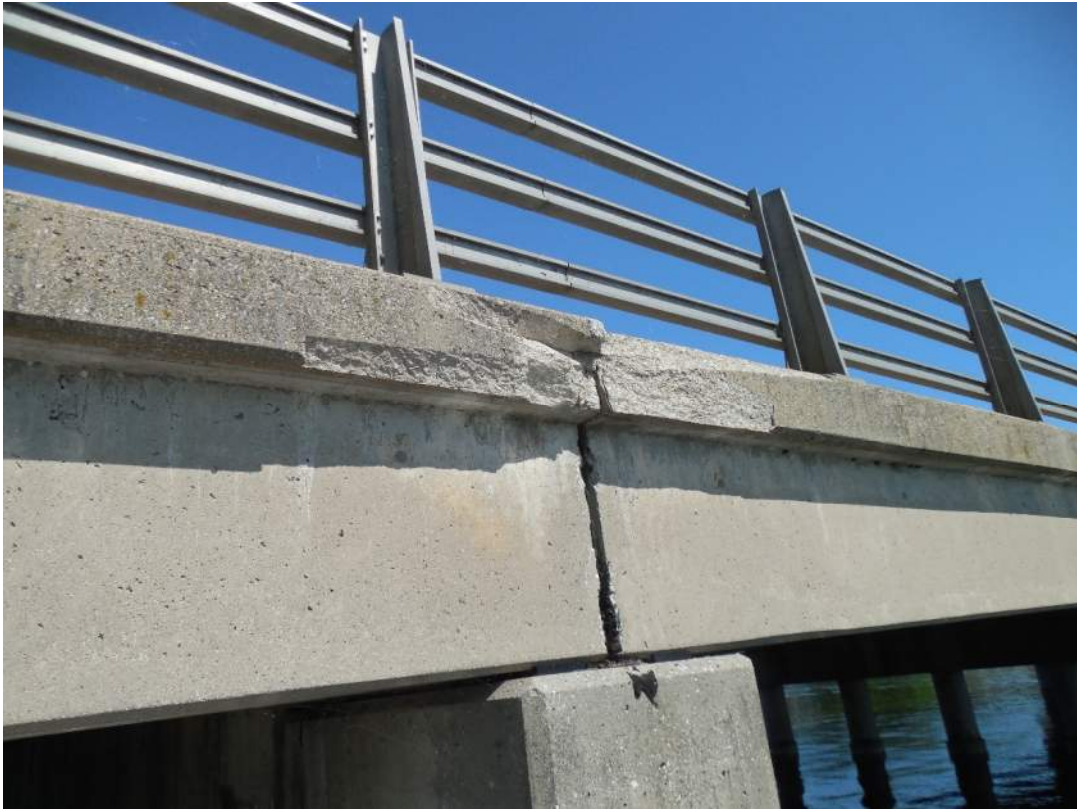
Spalling and grinding on east sidewalk fascia at Pier 2S

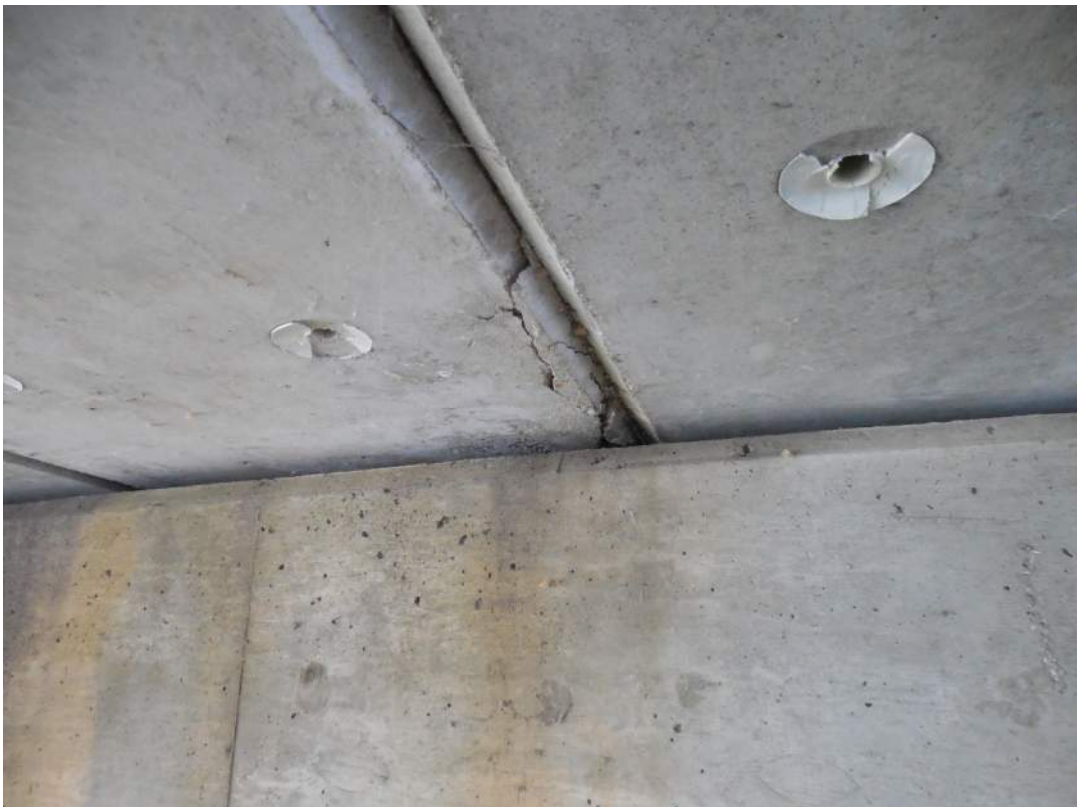
Span 2S, Beam 9W, cracking and delamination at Pier 1S

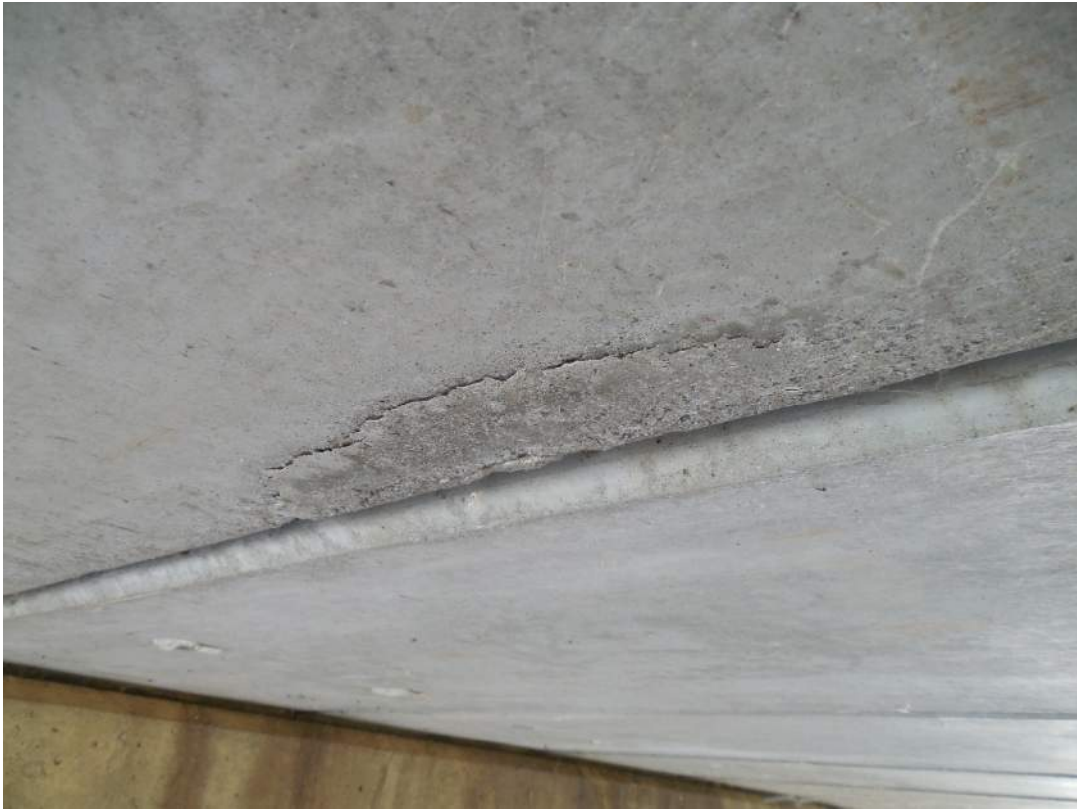
Span 1S, Beam 2W, cracking and delamination ~6' south of Pier 1S

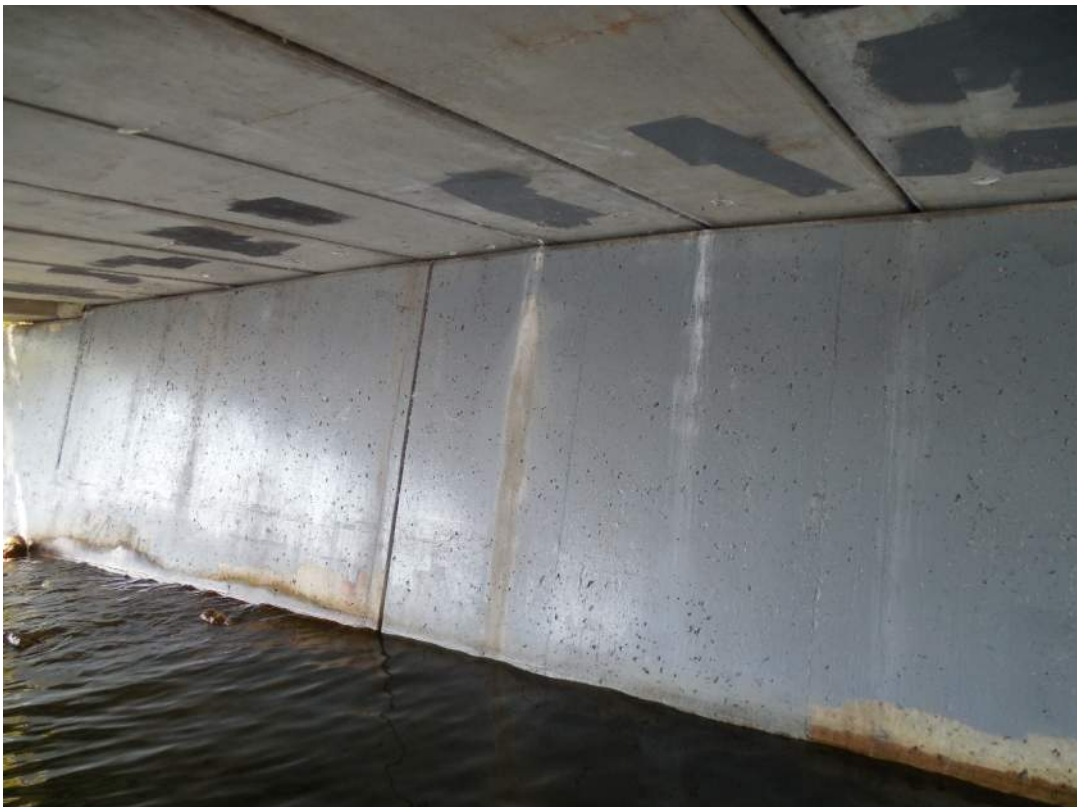
Evidence of leakage at box beam joints on south abutment

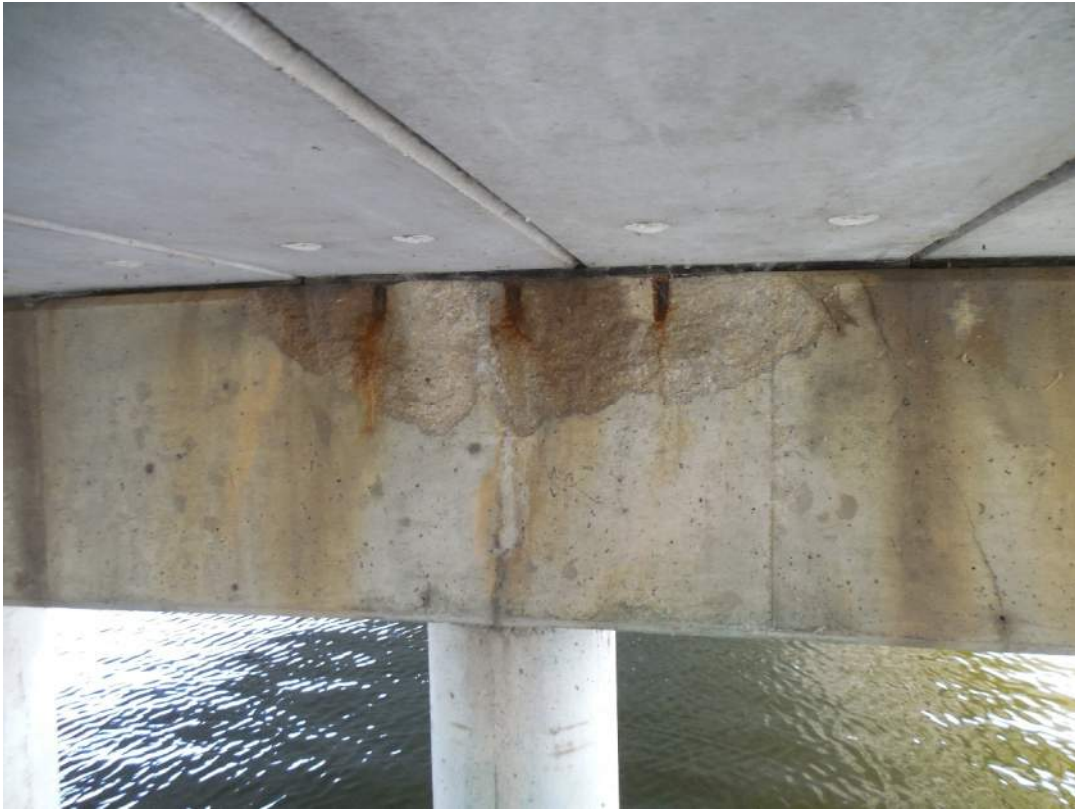
Pier 1S, south face, severe spalling with exposed positioning dowels at Beam 9W

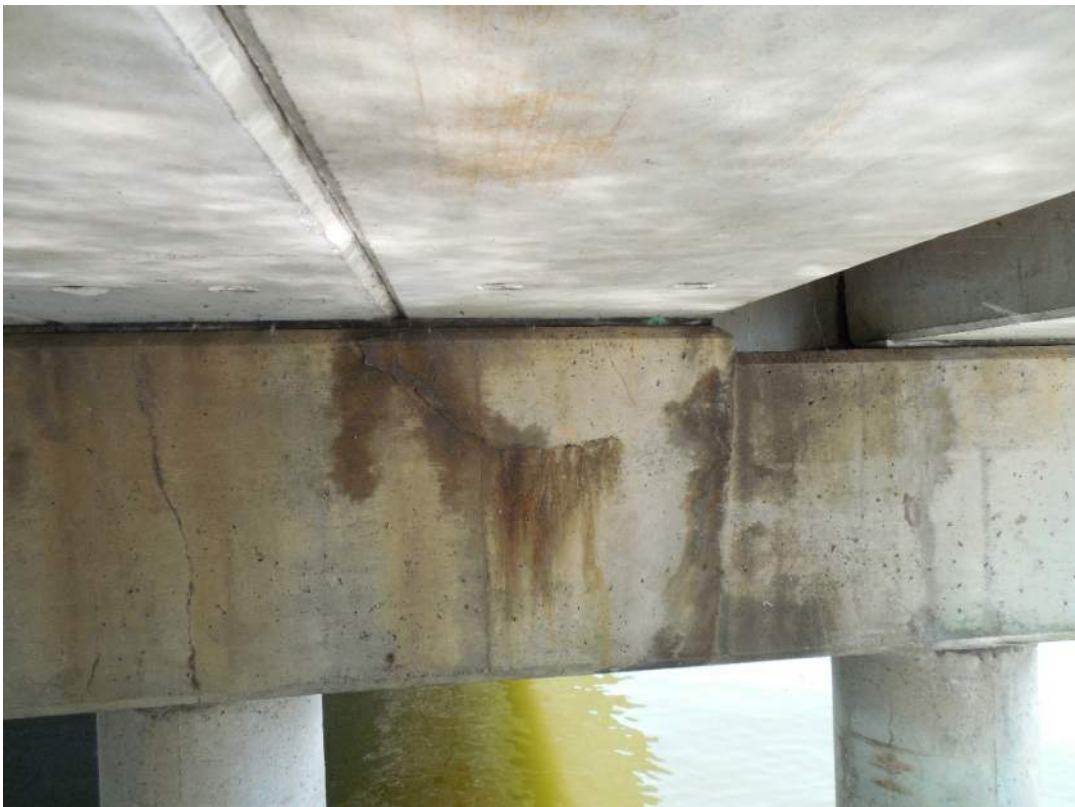
Pier 1S, south face, cracking and delamination at Beam 12W

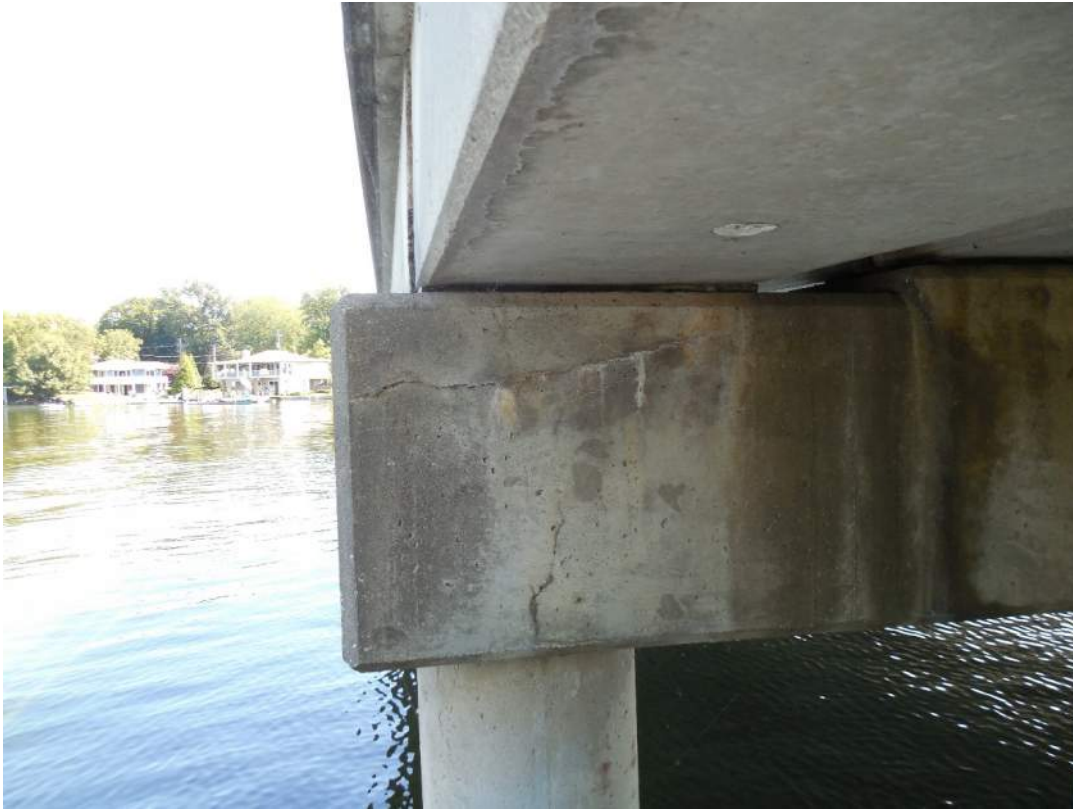
Pier 1S, south face, cracking and delamination at Beam 1W

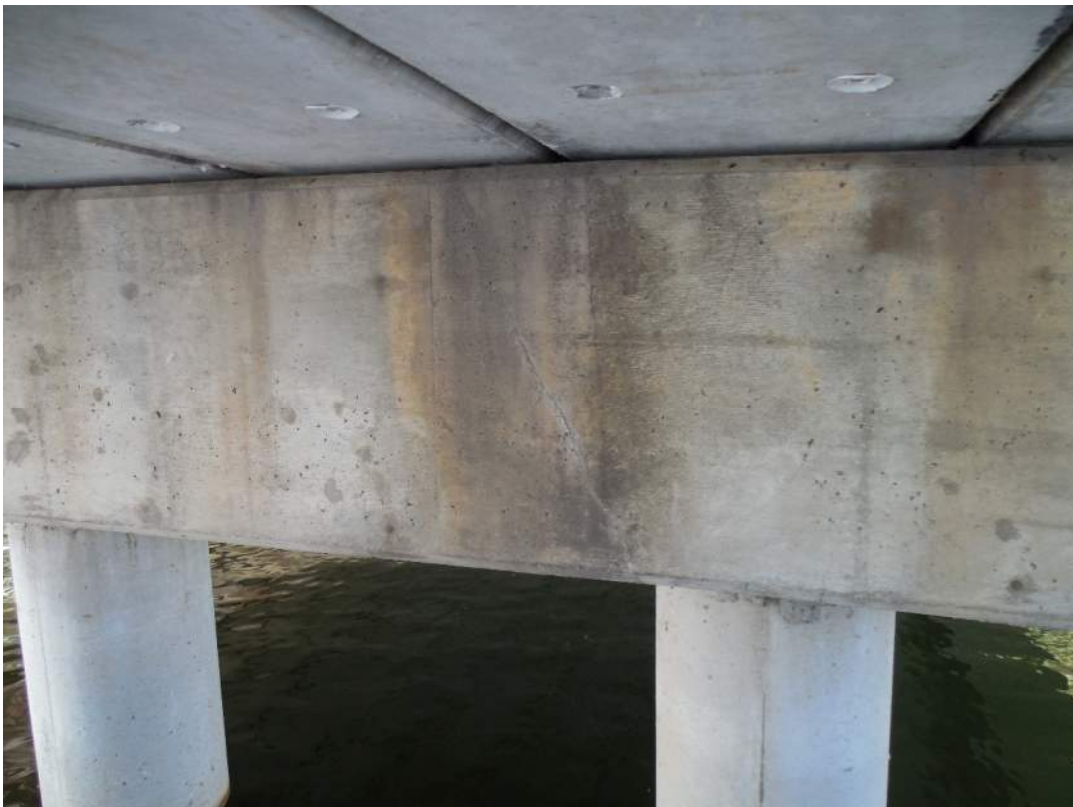
Pier 1S, north face, diagonal cracking at Pile 2W

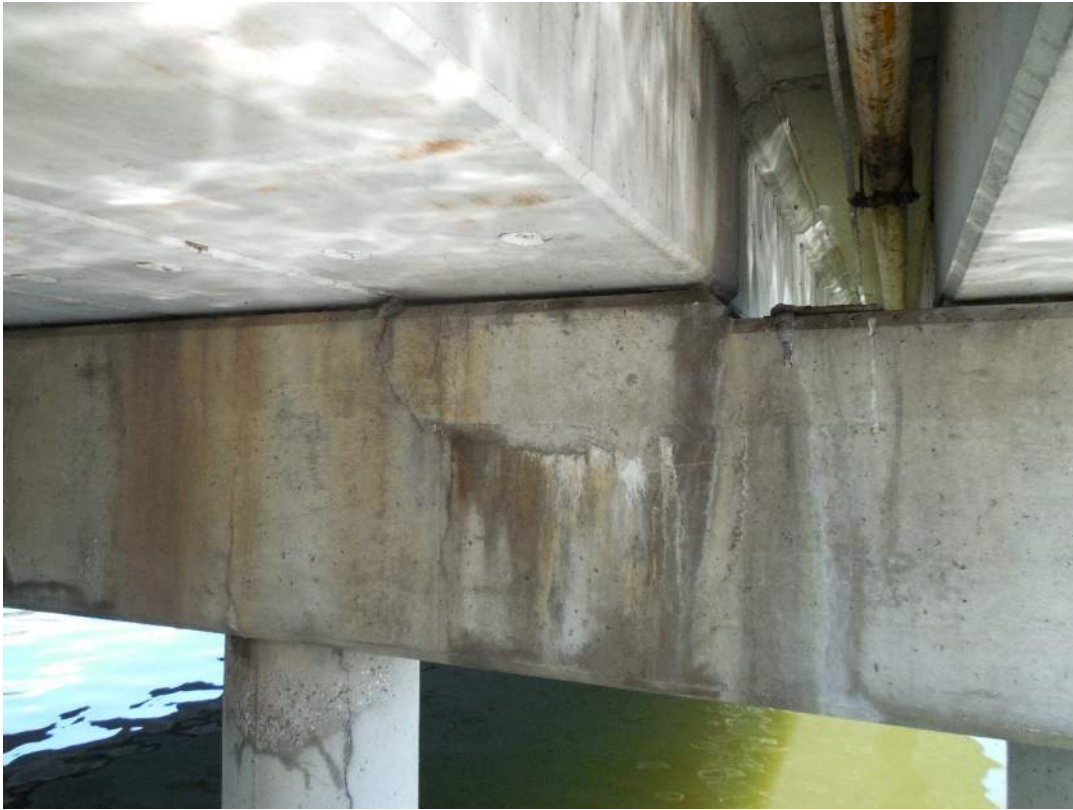
Pier 2S, south face, cracking and delamination at Beam 12W

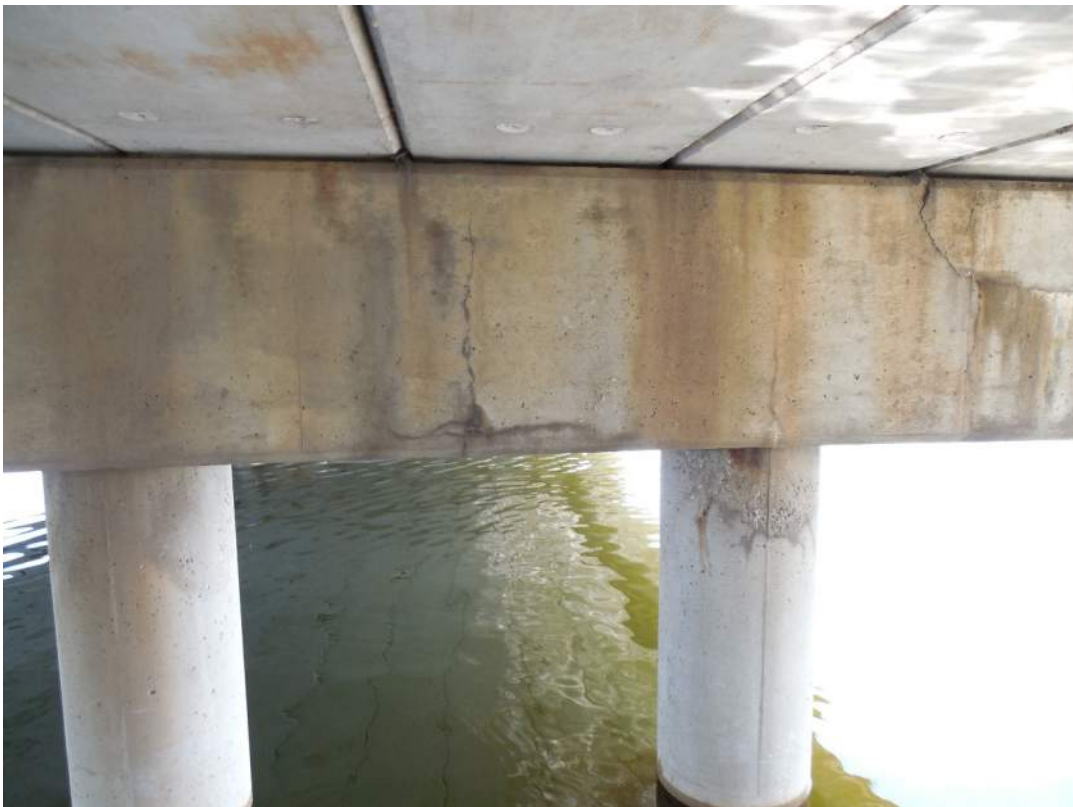
Pier 2S, south face, vertical and map cracking on concrete pile cap, honeycombing on pile jacket
