August 30, 2019

Mr. Craig Bessinger, City Manager
City of Ferrysburg
17290 Roosevelt Road
PO Box 38
Ferrysburg, MI 49409-0038

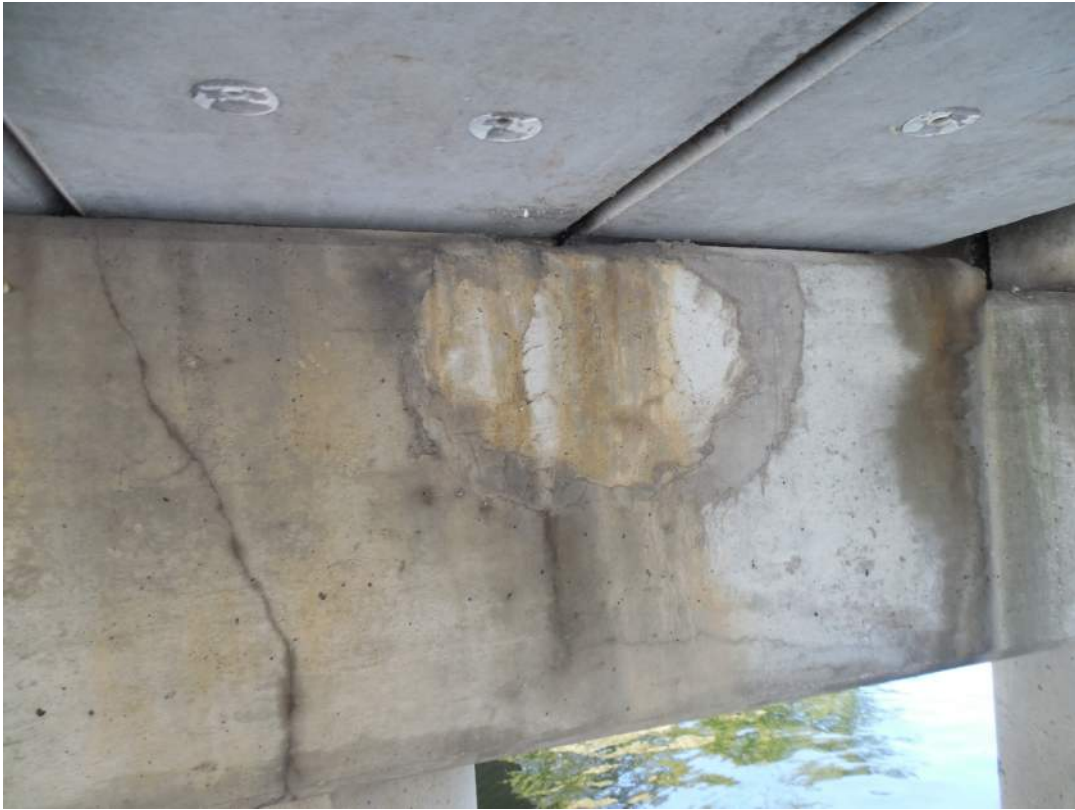
Pier 2S, north face, patched area at Beams 2W and 3W and vertical/diagonal cracking

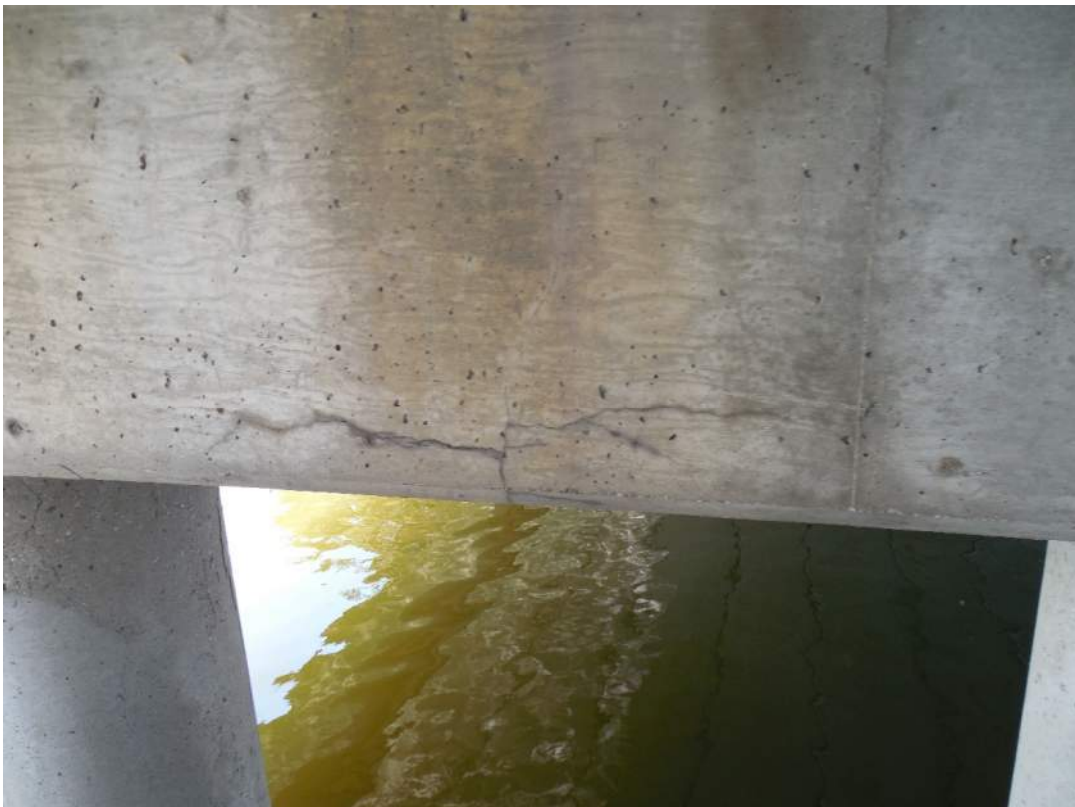
Pier 2S, north face, horizontal/map cracking near bottom of cap between Piles 4W and 5W

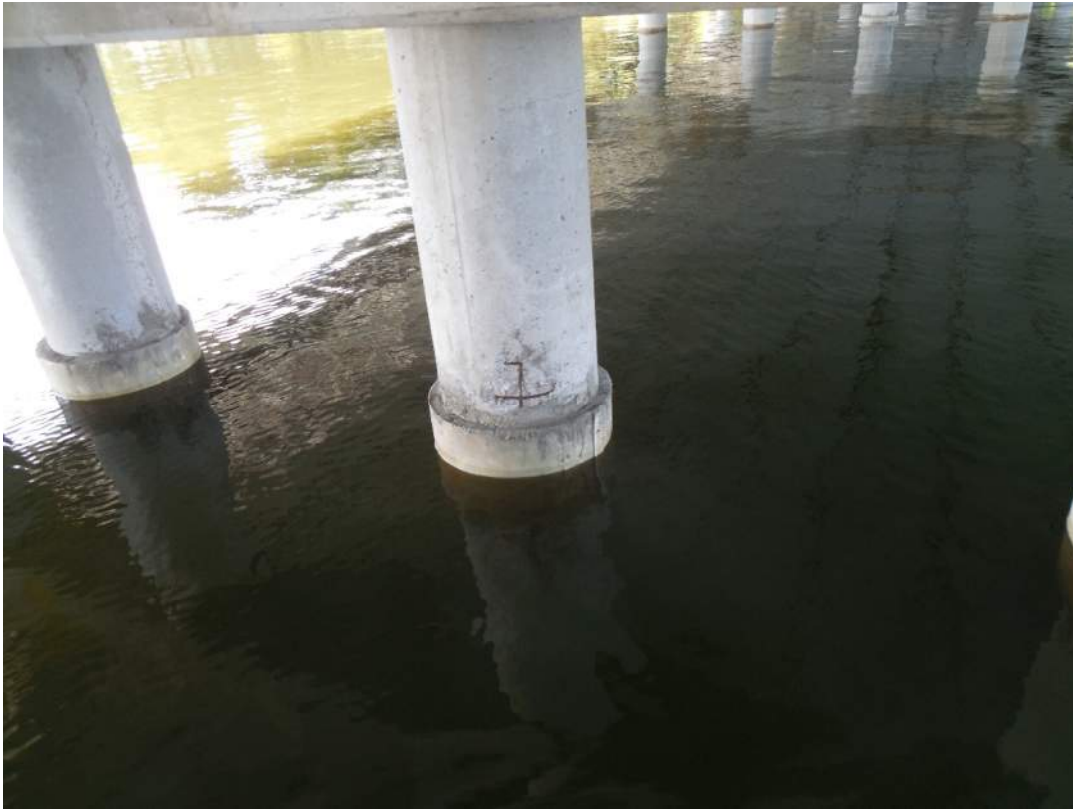
Pier 3S, north face, spalling with exposed steel in jacket of Pile 3W

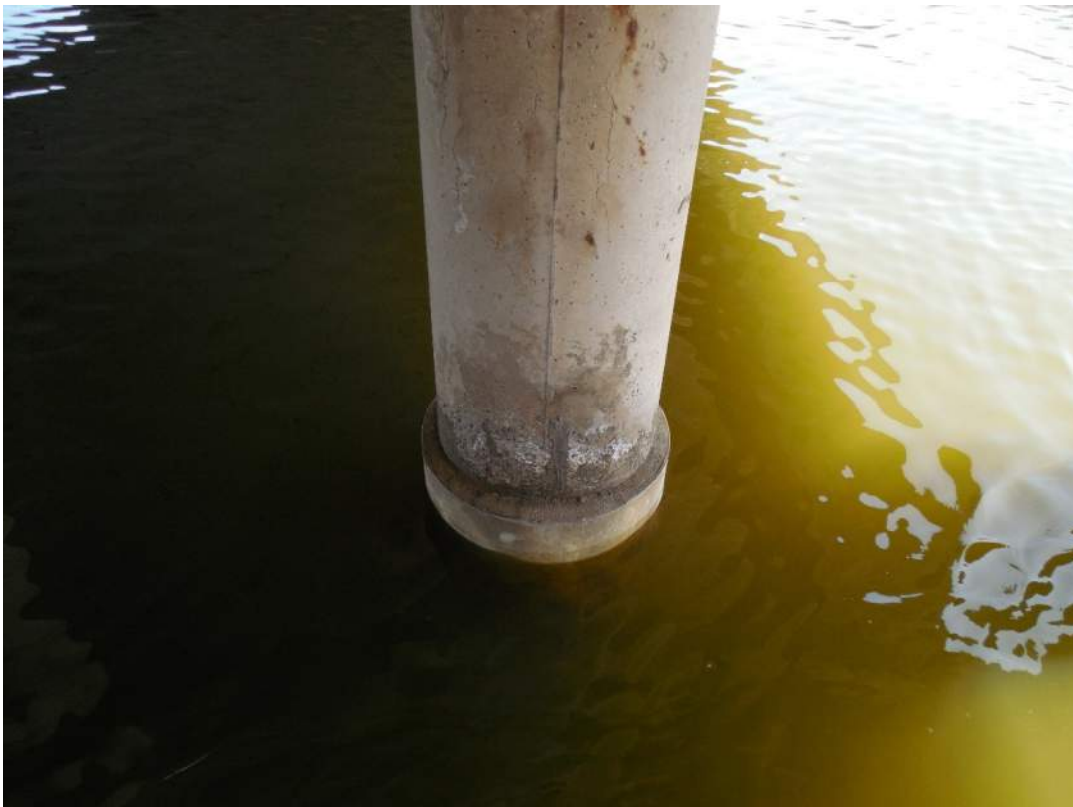
Pier 4S, south face, honeycombing and vertical cracking on jacket of Pile 5W

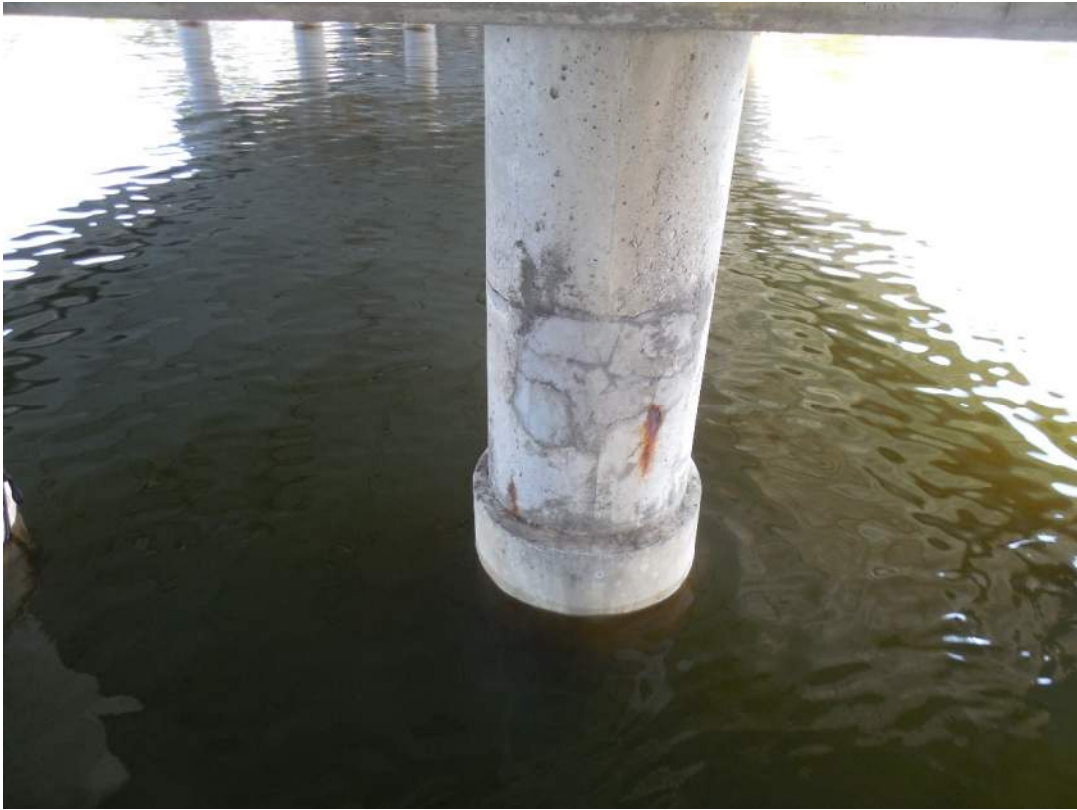
Pier 4S, south face, patching and rust staining on jacket of Pile 4W

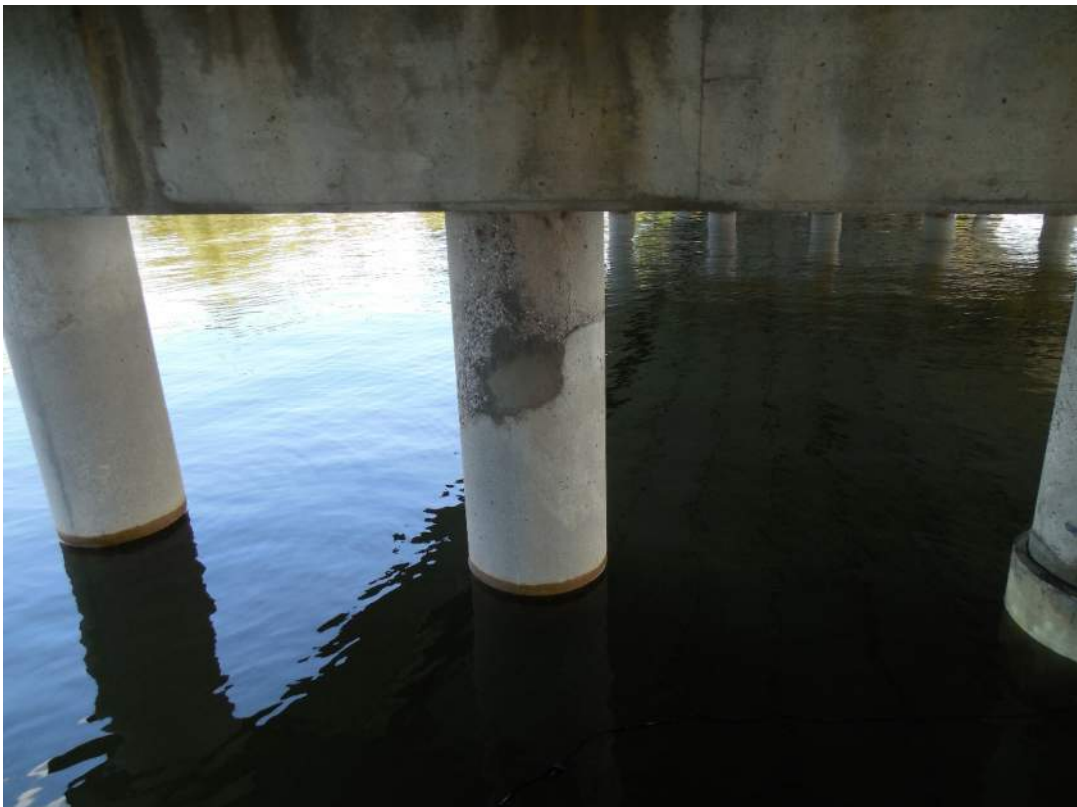
Pier 4S, south face, honeycombing and patching on jacket of Pile 2W

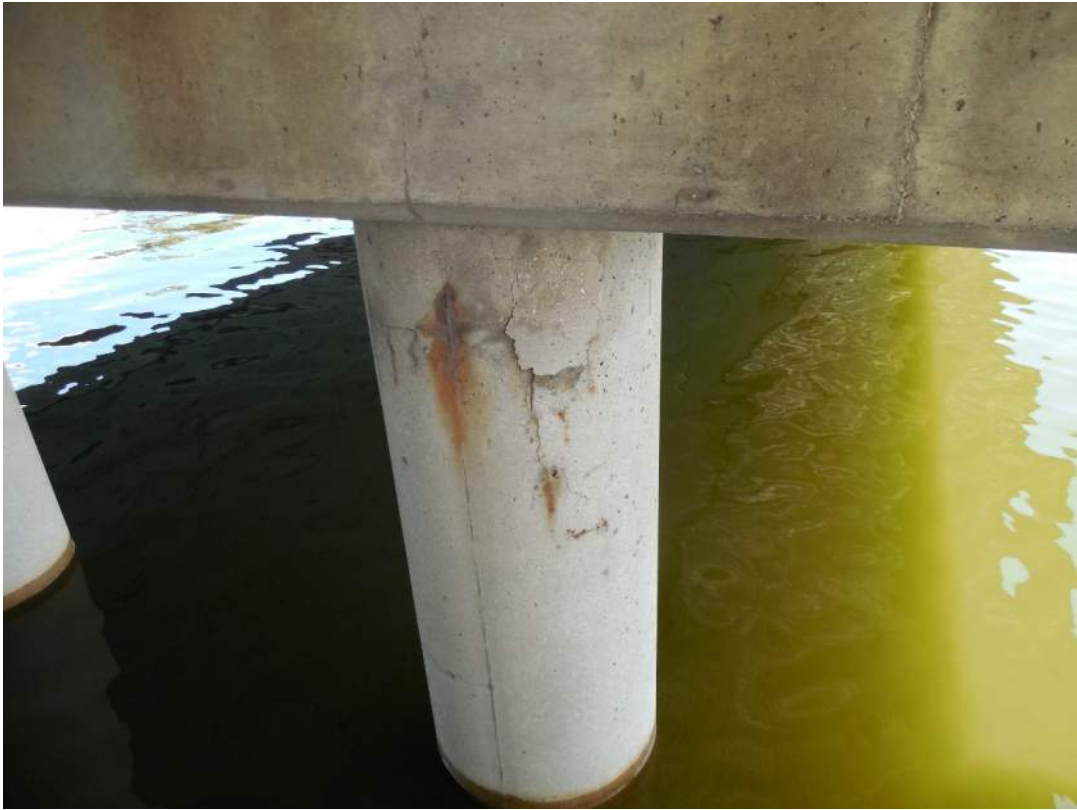
Pier 5S, south face, cracking and delamination on jacket of Pile 5W

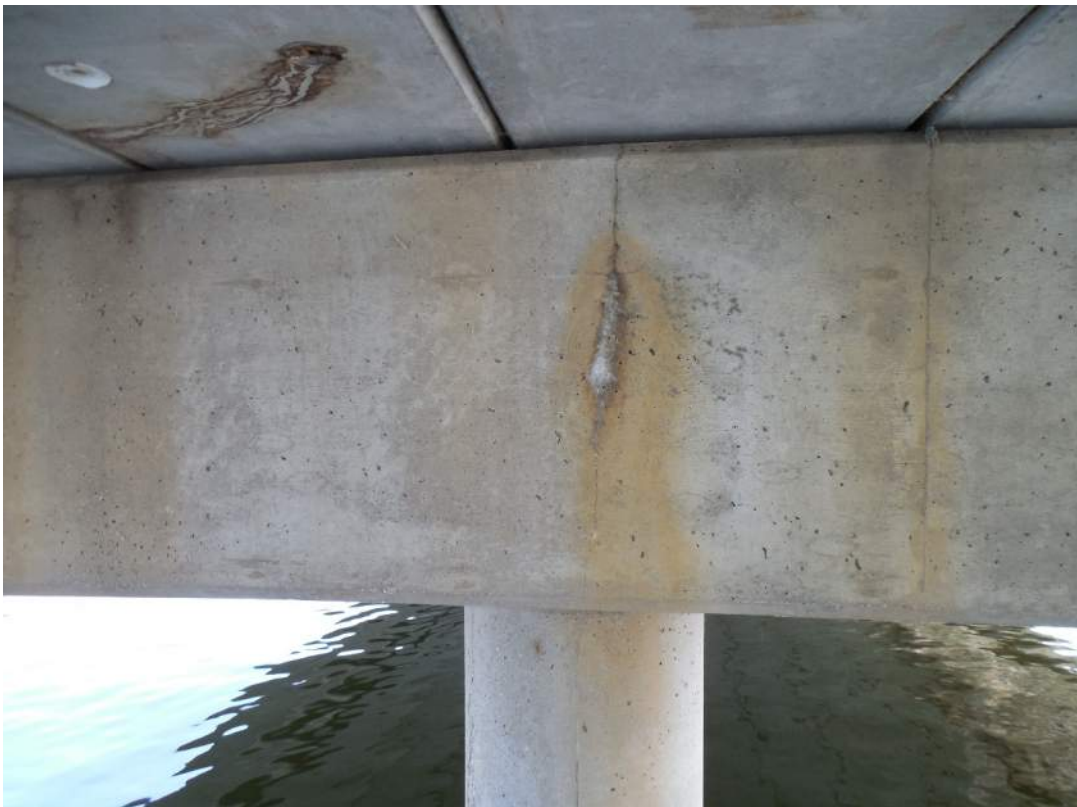
Pier 5S, south face, vertical cracking with efflorescence in cap at Pile 3W

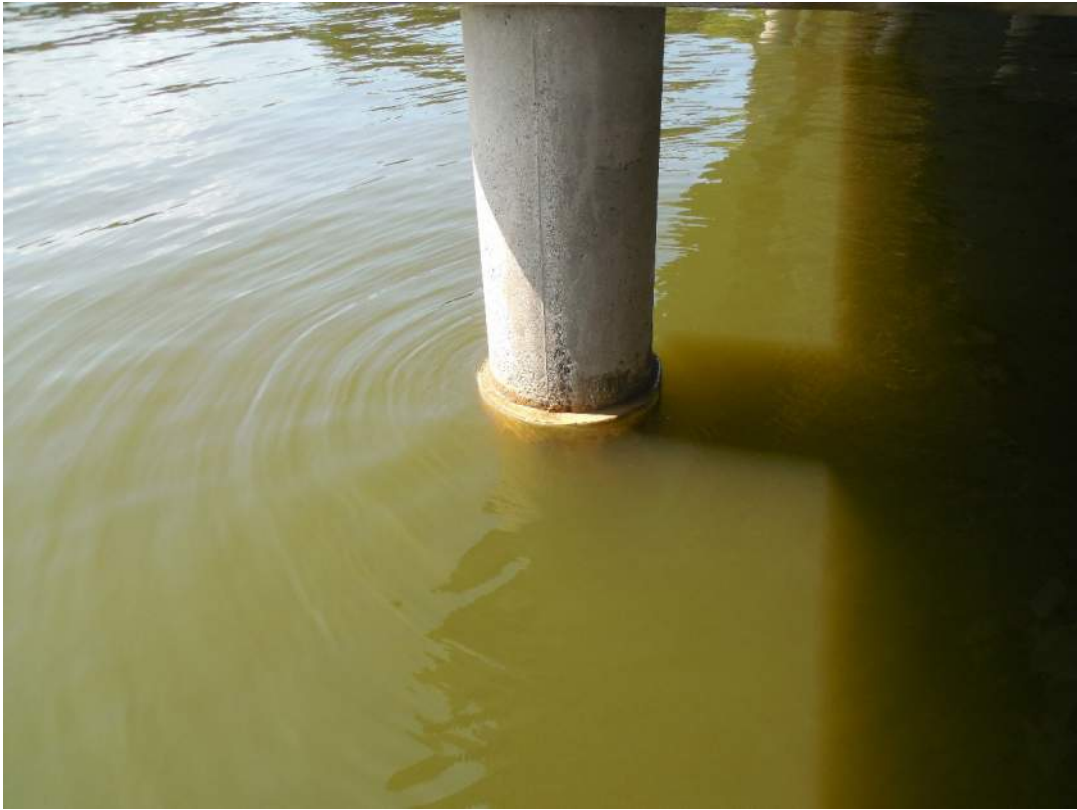
Pier 6S, north face, honeycombing on jacket of Pile 6W

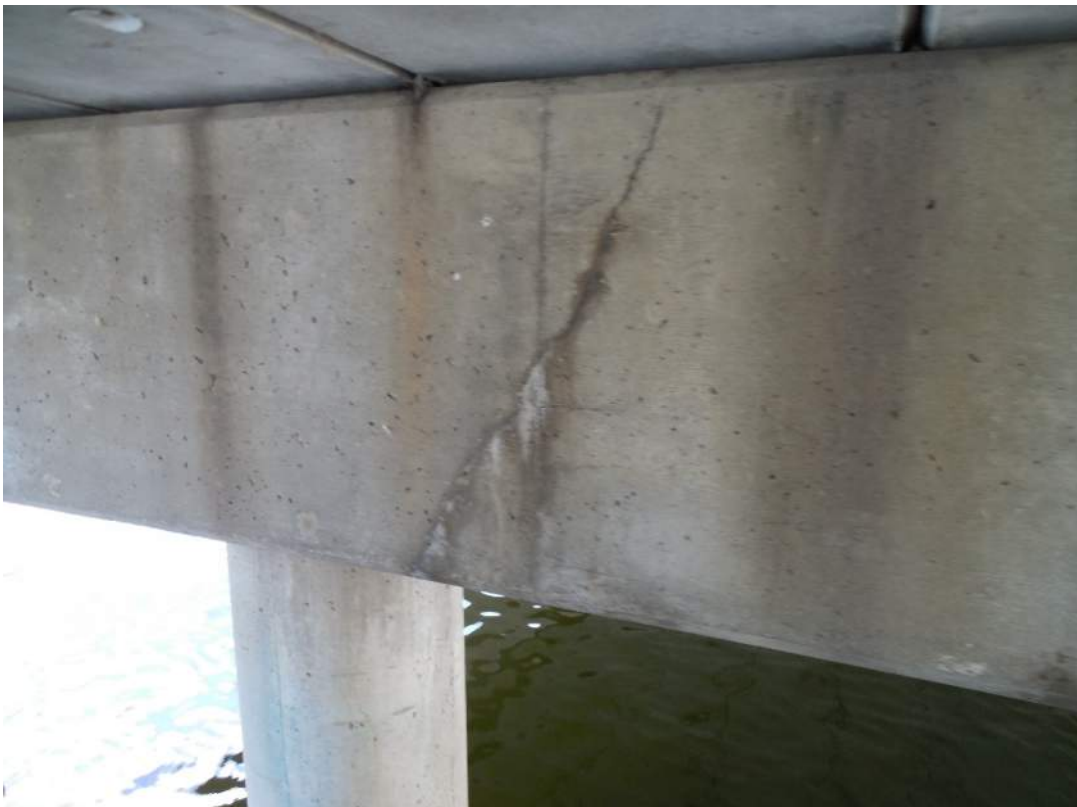
Pier 7S, south face, diagonal cracking with efflorescence on cap at Pile 2W

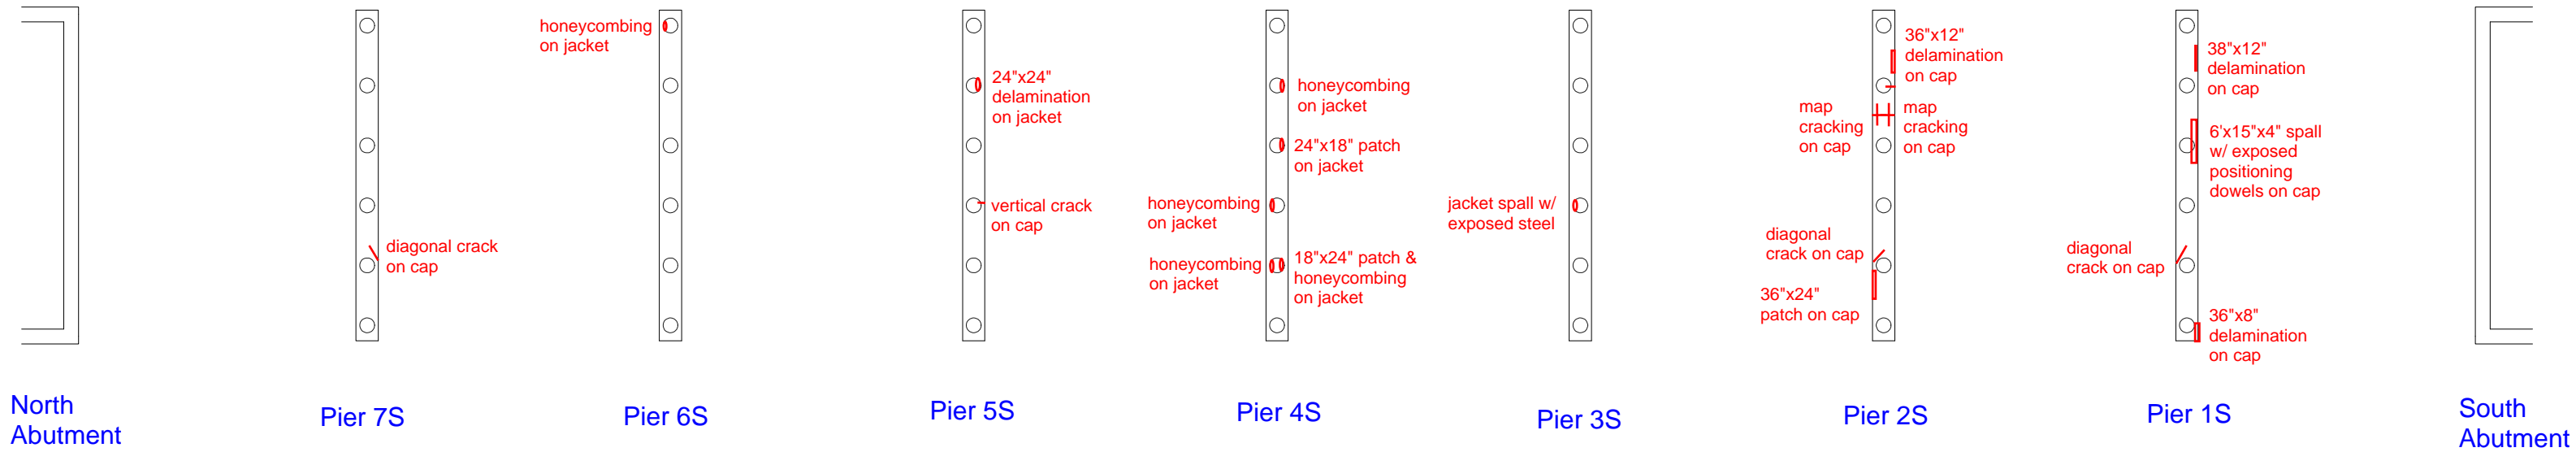
Pier Defect Locations

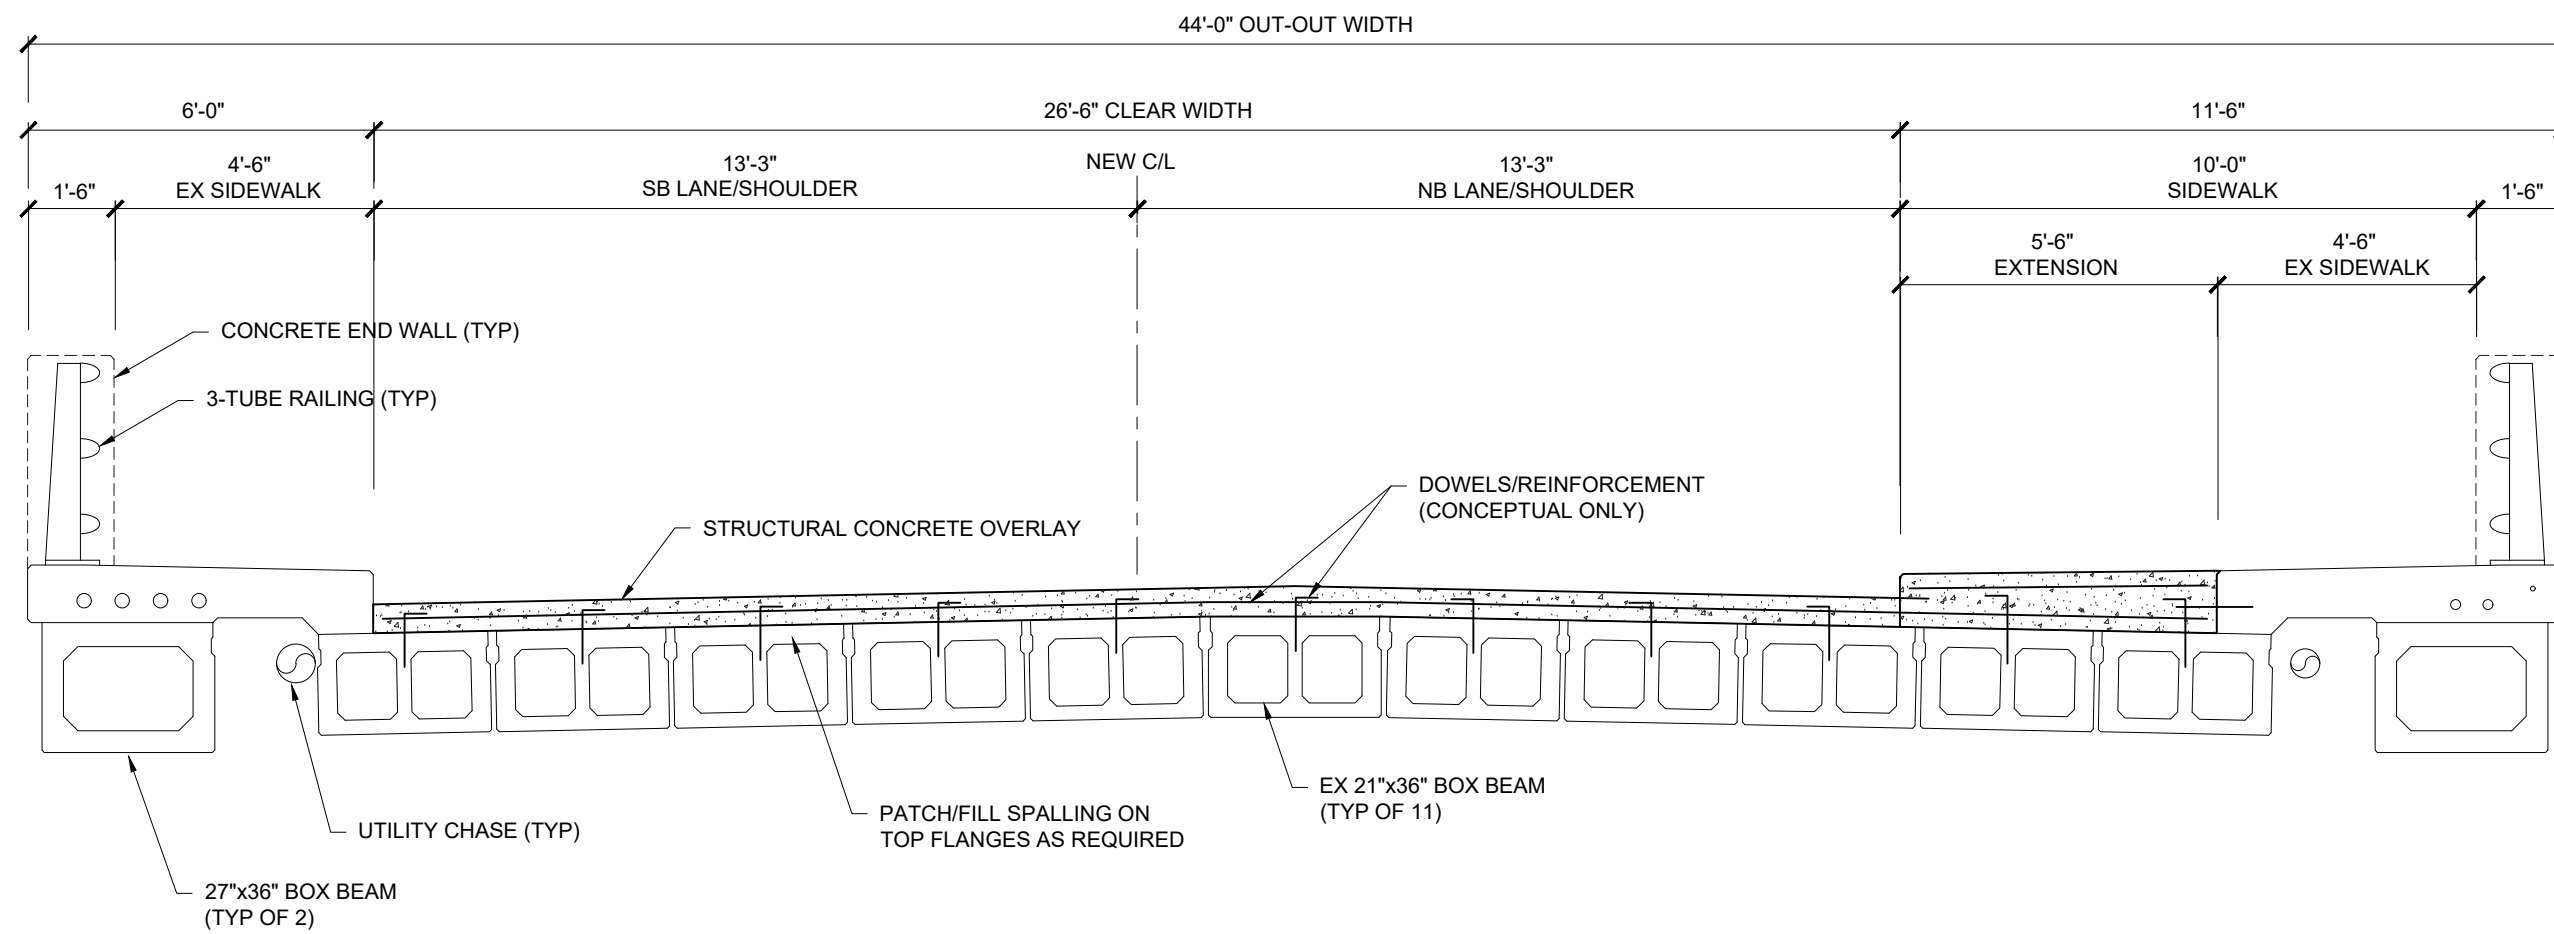
STRUCTURAL CONCRETE OVERLAY CONCEPT
NOT TO SCALE
